DAMAGE TO STRUCTURES

Water Supply Lifelines

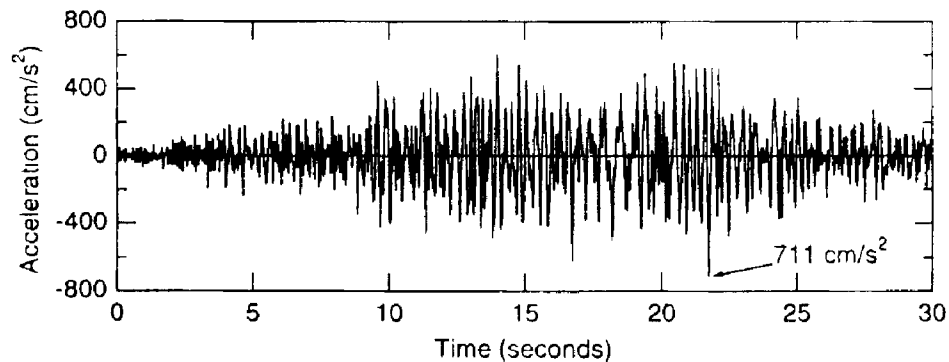
Fig.4 Time Record of Acceleration at Kushiro Meteorological Observatory³⁾

Strong motions were recorded at the Kushiro Meteorological Observatory which is located about 2.5 km southwest of Midorigaoka and 14 km north of the epicenter (see Fig.3 for location). Figure 4 shows a time record of acceleration. The peak acceleration and velocity are 711 cm/s^2 and 33.5 cm/s , respectively, and the duration of strong shaking is more than 20 seconds. A record with peak acceleration 922 cm/s^2 is also obtained at the ground floor of a building in the same site at a distance of about 20 m from the previous station. This site is located on the pleistocene terrace, which is considered to amplify the earthquake shaking in short period range resulting high peak value.

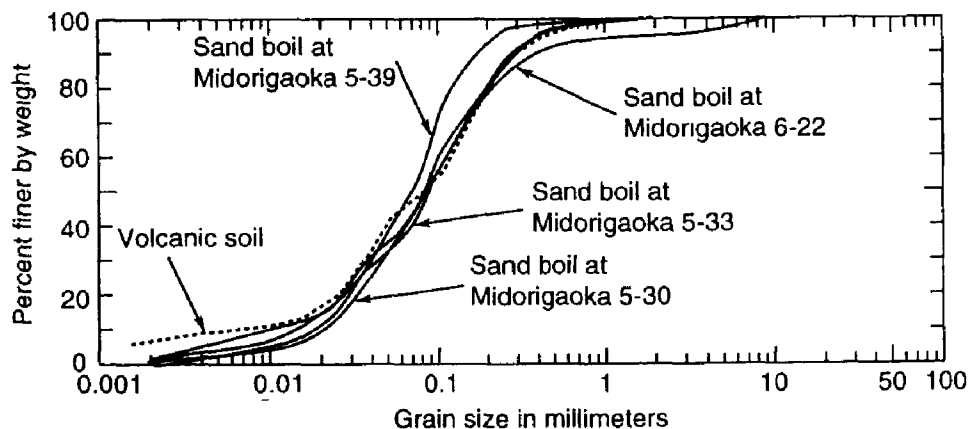
Fig.6 Grain Size Distribution Curves for Volcanic Ash Used as Fill Material²⁾ and Sands Collected from Sand Boils in Midorigaoka

Figure 6 is a comparison of the grain size distribution curves of sands from sand boil deposits at different locations in Midorigaoka and natural volcanic ash which is generally used as fill material in this area. Both soils have similar grain size characteristics, which implies that volcanic fills were liquefied during the earthquake, and may be natural material.
