## **B.- INSTALLATIONS OF THE MAIN HOSPITAL OF SAINT VINCENT, W.I**

### **B.1.- GENERAL DESCRIPTION**

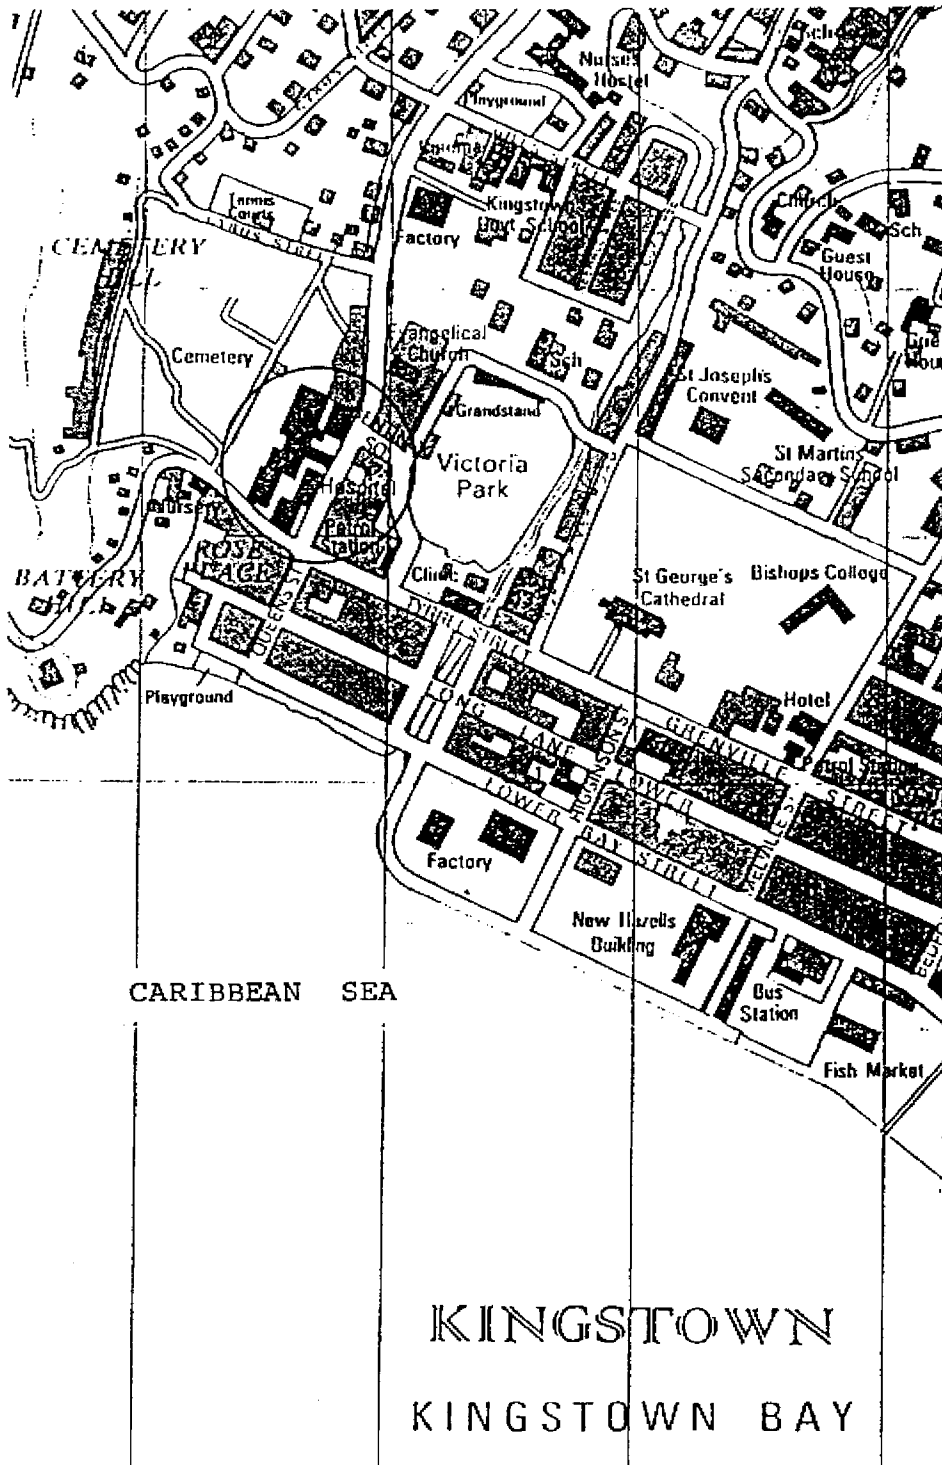
**FIGURE B.1 LOCATION OF THE KINGSTOWN HOSPITAL, SAINT VINCENT**

The Kingstown General Hospital is located in the western extreme of the city, about 200 meters of the coastal line, within the urban zone. In Figure B.1 its location is indicated and in Figure B.2 a site survey is presented; the dimensions, indication of the geographic North and separations between buildings are only approximated. On the West side it neighbours with the city's cemetery.

The area actually occupied by the health care installations has an approximate extension of 8.900 m<sup>2</sup>, with a slope from the North-West towards the sea (see Figure B.1). The slope between the extremes of the lot, in the indicated direction, is of about 4 meters (see Photos 1 through 5).

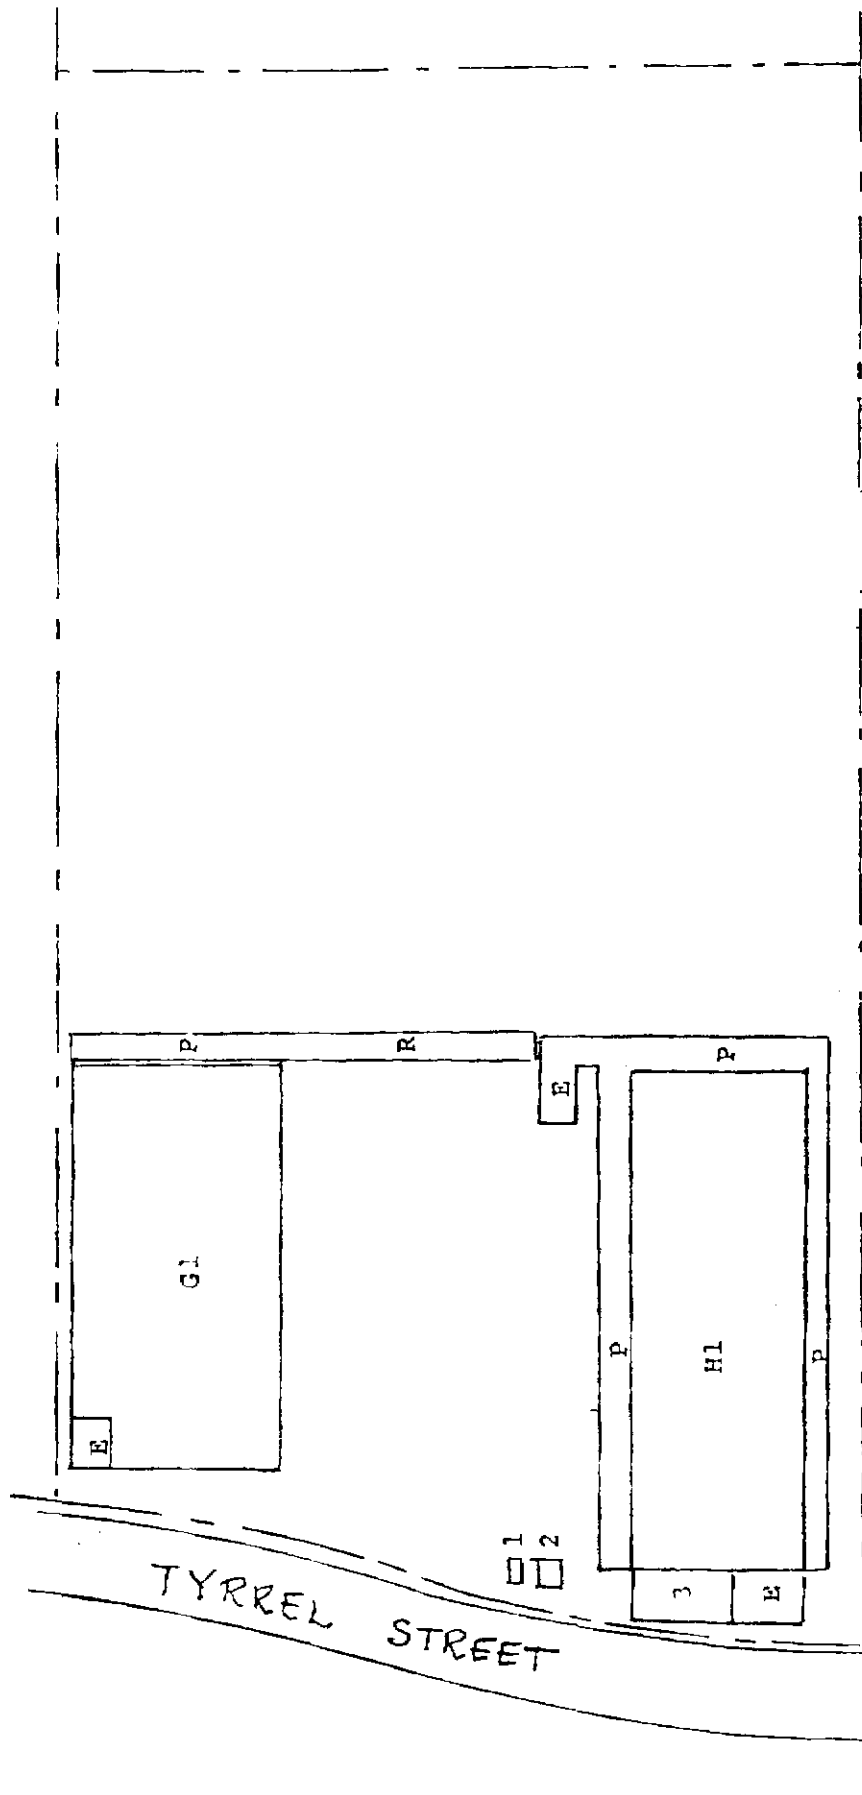
FIGURE B3 SAINT VINCENT HOSPITAL (Level 0)

- 1: DIESEL FUEL TANK
- 2: HIGH VOLTAGE TRANSFORMER
- 3: PACK-UP GENERATOR
- E: CIRCULATION STAIRS
- G1: PAEDIATRICS
- H1: MEN HOSPITALIZATION
- P: CORRIDORS
- R: RAMP
