7. CASE STUDIES ON EFFECTIVE COUNTERMEASURES OF FOUNDATIONS AGAINST LIQUEFACTION AND LARGE GROUND DISPLACEMENT

7.1 Foundations of Facilities of Sewage Plant

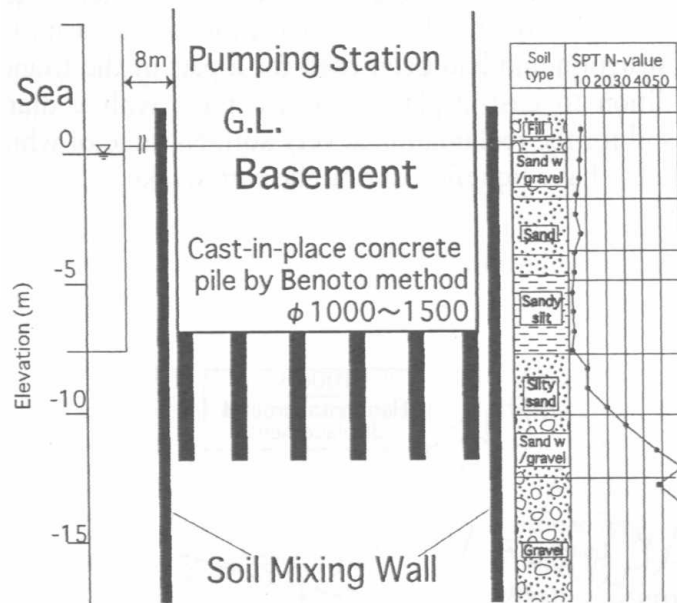
Figure 34. Cross section of Shimagami Pumping Station

The Shimagami pumping station located along a shoreline at Nagata ward in Kobe City. The distance of the building from the quaywall is only 8 meters. As shown in Figure 33 the quaywall moved towards the sea at a maximum about 3 meters, and consequently the ground behind the quaywall displaced toward the sea. However, the building of the pumping station with a height of about 16 m hardly suffered any damage, besides the surrounding ground subsided more than 1.0 meter. This building has a basement about 8 m deep for northern half of the building and about 11 m for southern half, and is supported by cast-in-place concrete piles of diameters of 1.0-1.5 meters as shown in Figure 34. An inground wall, named as SMW (Soil Mixing Wall), with a width of 45 cm, was built for the excavation of the basement. This inground wall remained after the construction of the building and surrounded the concrete piles. It can be guessed that the existence of the inground wall had a great influence to prevent damage to the foundation piles, in addition to the existence of the basement.

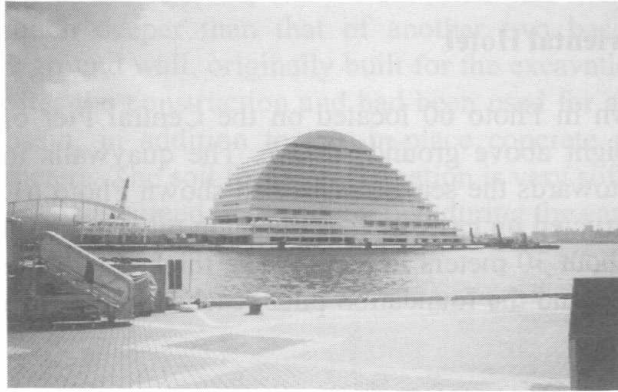
Photo 60 Oriental Hotel on Central Pier of Kobe Port

The Oriental Hotel shown in Photo 60 located on the Central Pier of Kobe Port, and has 60m height above ground surface. The quaywalls in front of the building moved towards the sea and subsided shown Photo 61. The hotel building was constructed on cast-in-place concrete piles of about 1.0 meters in diameter and about 30 meters in length. The thickness of the reclamation is about 12 meters and the foundation piles reached into a firm Pleistocene gravel layer.

It was reported that at the stage of the structural design of this building, lateral flow of the liquefiable soil beneath the building towards the sea was considered to seriously affect the stability of the building²⁶⁾. Therefore, inground walls was designed and constructed to avoid the lateral flow of foundation ground. As shown in Figure 37, the inground walls, consisted of continuous cast-in-place piles of 1.0 meters in diameter and 12-19 meters in length, were constructed by mixing cement slurry into the ground, and the wall reached into non-liquefiable soil layer through the reclaimed liquefiable layer. It was reported that this hotel building did not suffer any structural damage and any settlement, and that no trace of the liquefaction was found on ground surface under the building, when the foundation was excavated after the earthquake²⁶⁾.

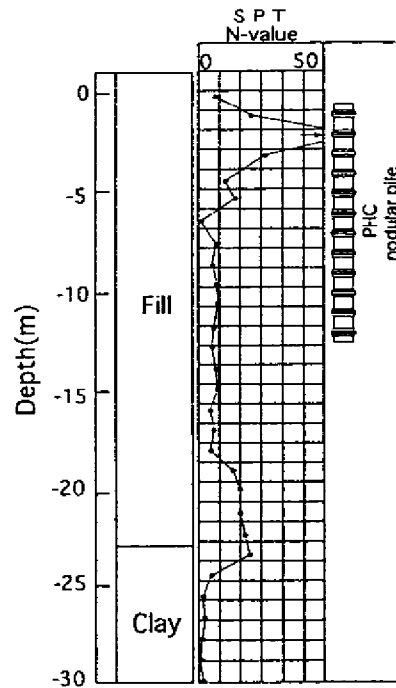
Figure 39. Soil Profile at Site A in Figure 38

Three warehouses were built near quaywalls in Rokko Island as shown in Figure 38 and supported by prestressed high strength concrete piles 40-50 cm in diameters. The piles 12 meters long installed into drilled holes and bounded to the ground by casting gravel into the gap between the piles and the drilled holes. The piles had many nodes and as shown in Figure 39, which induced large friction force between the ground (so-called nodular friction pile). During the earthquake sand boils occurred nearby ground and the quaywalls in front of the warehouses moved horizontally by 3-4 meters as shown in Figure 38. All of warehouses, although located about 30 m from the quaywalls, sustained no damage to the pile foundations as well as super structures²⁷⁾. This is probably due to the compaction effect during the pile driving as well as drainage effect of the gravel around the piles in addition to flexibility of the piles. Similar examples of good performance of nodular friction pile foundations against large ground displacement were reported at Pier No. 2 of Maya Wharf and northwestern corner of Port Island²⁷⁾.
