Buildings and Earthquake Vulnerability in Eastern Anatolia

2.4 Earthquake Field Studies

2.5 Mechanism of Damage and Failure

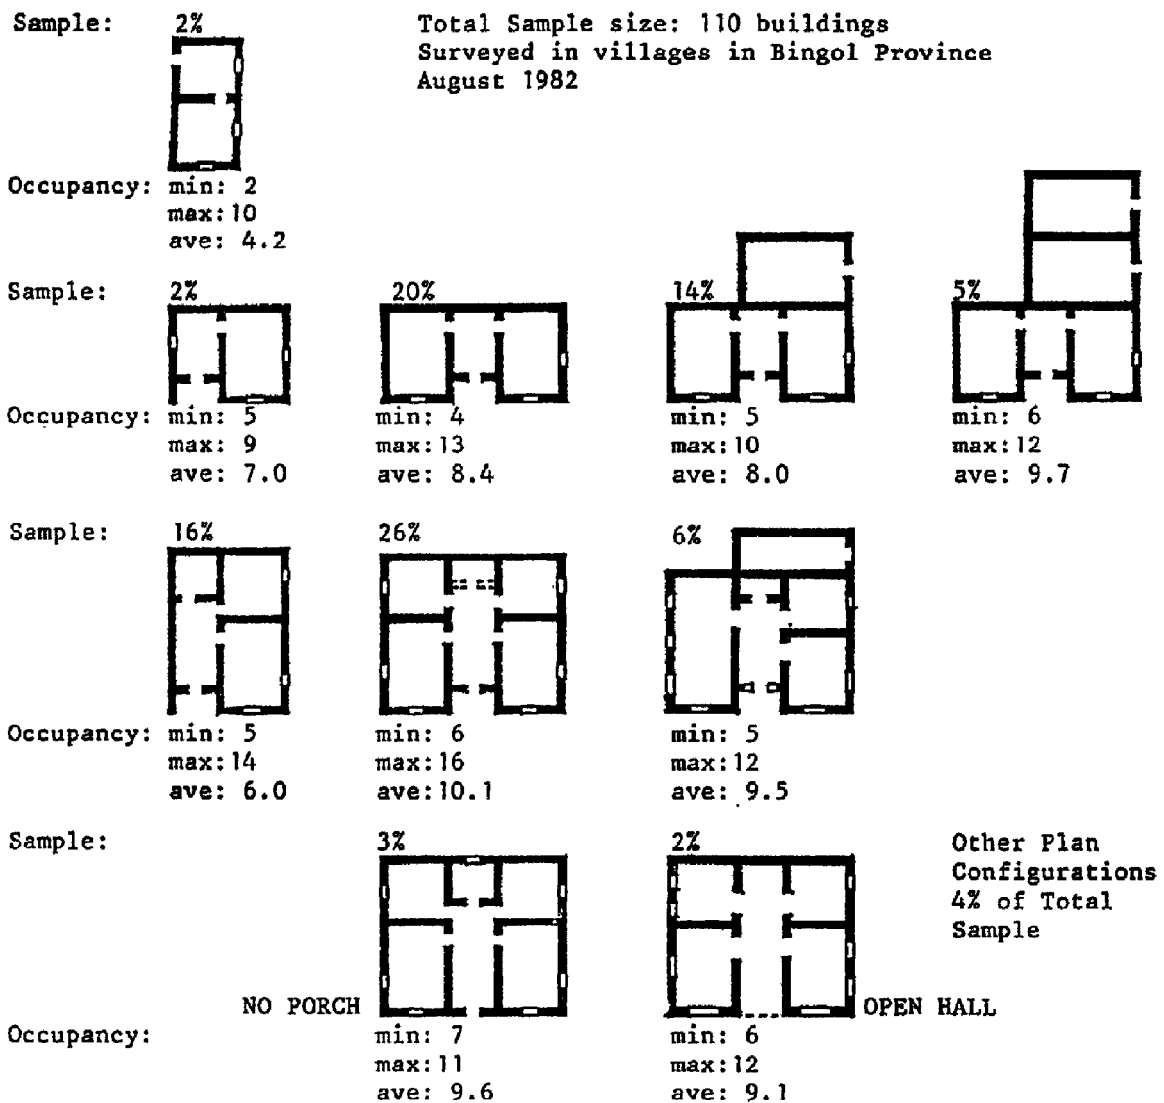
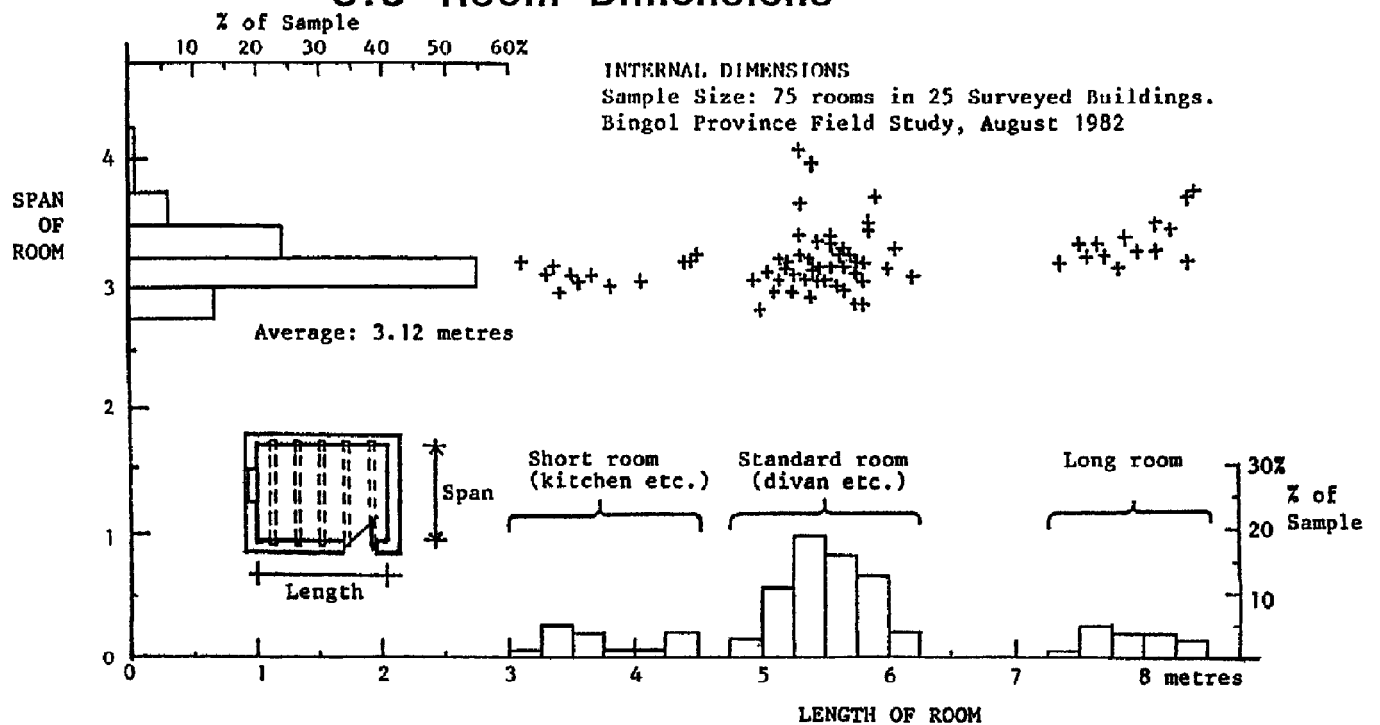
Figure 2.2 Plan Types of Traditional Buildings
a) Variations in plan types
b) Room dimensions of surveyed sample

The plans of the houses are relatively uniform, consisting of a collection of structural 'cells'- simple rectangular rooms- joined in fairly standard configurations. In figure 2.2(a) it can be seen that the basic form of a central hall with living rooms either side is found in a number of variations. The central entrance hall is an important focus of the house and varies considerably in its use and architectural expression. The dimensions of these rooms are quite consistent from building to building, as shown in figure 2.2(b).

The span of the rooms, controlled by the length of timber available for roof beams, is surprisingly consistent; over half of the rooms surveyed had a span of between 3.0 and 3.25 metres. The length of the structural unit is much less uniform but appears to fall into one of three categories; a short room, almost square in plan, used for cooking, ablutions or other small volume room; a standard room between 5 and 6 metres long, used for most living and sleeping areas; and a less common long room, up to 8.5 metres long, used for the prestigious salon rooms for sitting or formal meetings. The external height of these structures is also fairly standardised at between 2.5 and 3 metres from floor to eaves on flat ground.
