Effects on Lifelines

*E. Crespo,** Cornell University, Ithaca, New York
*T. D. O'Rourke,** Cornell University, Ithaca, New York
*K. J. Nyman,** Cornell University, Ithaca, New York

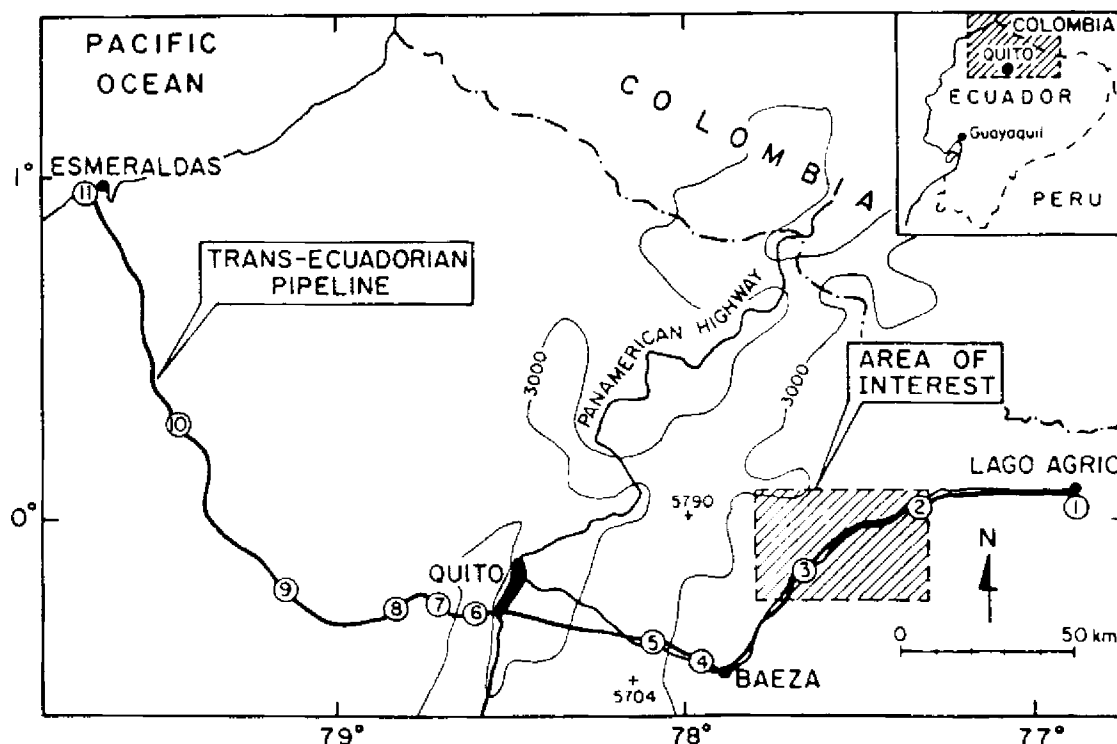
FIGURE 6.1 Route and station locations of the Trans-Ecuadorian pipeline.

Figure 6.1 shows a plan view of the Trans-Ecuadorian pipeline, with pump stations at locations 1 through 5 and 10, and pressure-reducing stations at locations 6 through 9. The endpoint of the pipeline at the Balao marine terminal is situated near Esmeraldas at location 11. The pipeline conveys oil from an initial elevation of 296 m at the Lago Agrio pump station to a maximum elevation of 4,060 m at a mountain pass E of Quito to the Balao marine terminal at sea level. The elevations relative to sea level of the various pump and pressure-reducing stations are summarized in Table 6.1. For purposes of clarity, the Poliducto pipeline is not shown, although it should be recognized that this facility follows the same right-of-way corridor from Lago Agrio to Quito as illustrated in the figure.

The remaining 298 km of the pipeline from E of Quito to Esmeraldas is buried. One section of the line, from location 8 to 9 as depicted in Figure 6.1, is composed of 510-mm-diameter pipe. All other sections are composed of 660-mm-diameter pipe.

The area of most severe disruption is shown by means of the hachured zone in Figure 6.1. It was in this general region that landslides and floods triggered by the earthquake damaged the line pipe and the Salado pump station (location 3).
