ANEXO 1

#### 4.6.5 Estructura de la Edificación.

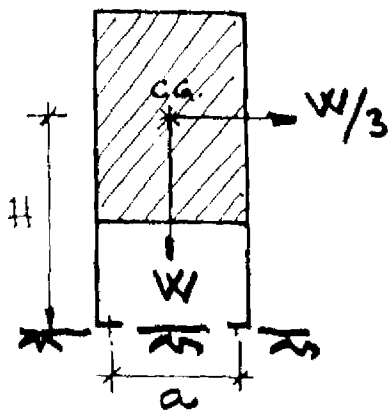
- d) En la Sala de Máquinas (cuerpo E), así como en el patio exterior de almacenamiento de oxígeno y de gas combustible, se identificaron instalaciones no ancladas. Estos equipos deben fijarse a sus bases por medio de pernos embutidos en ellas con un diámetro  $d$  por lo menos igual al estimado en la forma siguiente:

$$d = \frac{1}{\pi} \frac{W H}{12 a} - \frac{W}{8} \quad (\text{cm})$$

W = peso en toneladas

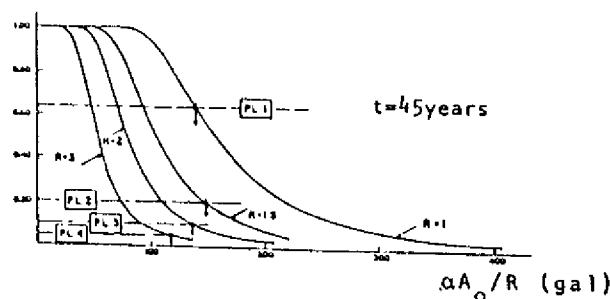
FIGURE 1: PROBABILITY OF EXCEEDENCE OF  $\alpha A_0/R$  AND PERFORMANCE LEVELS GIVEN IN TABLE 6.

Figure 1 gives typical hazard evaluation results, in terms of maximum ground acceleration (as Ec (2)), for a 45 years life span. It also shows in a graphical form the application of the criteria established in Table 6. Similar results for three different sites are given in Table 7, where PL2 happens to be the critical performance level for Sites 1 and 2, and PL1 for Site 3. This result shows, among other things, that the importance factor  $\alpha$  can not be taken as a constant.
