**A SEISMIC ASSESSMENT OF AN EXISTING WATER TREATMENT PLANT
AND AN EXISTING WASTE WATER RECLAMATION PLANT, SALT LAKE CITY, UTAH**

**Lawrence D. Reaveley
Reaveley Engineers and Associates, Salt Lake City, Utah**

As part of a study to assess the seismic vulnerability of the city facilities that have been determined to be essential, the main culinary water treatment plant and the main waste water treatment plant have been evaluated. "Essential" facilities are "those structures or buildings which must be safe and usable for emergency purposes after an earthquake in order to preserve the health and safety of the general public" (International Conference of Building Officials, 1985). This paper is a summary of the findings of a portion of the overall study.

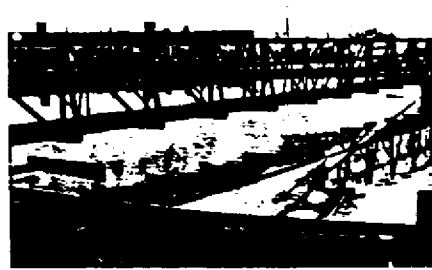
PRIMARY TREATMENT

Primary treatment physically removes settleable and floatable solids from the wastewater by passing it through large sedimentation tanks.

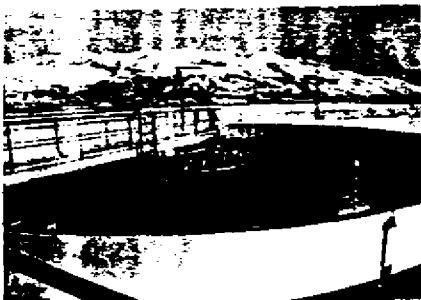
WASTEWATER SOLIDS PROCESSING

Wastewater solids (sludge) that settle out in primary and secondary sedimentation are pumped to a common thickening tank before digestion.

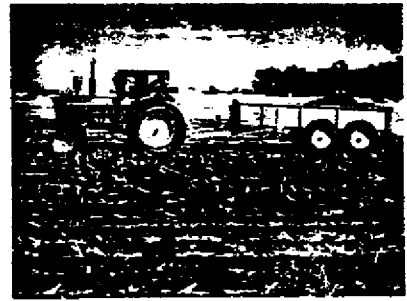
Digested sludge is dewatered by air drying and applying it to agricultural land as a soil conditioner and nutrient supplement.

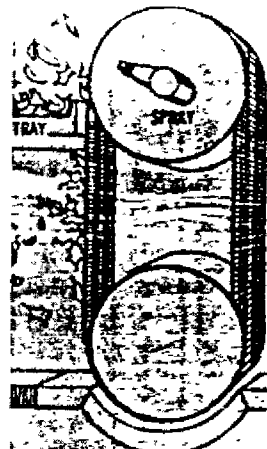
2. SCREENS

Traveling leaf screen removes leaves. High pressure water spray cleans screens, tray conveys leaves to outside for disposal.
