DESIGN, CONSTRUCTION AND PERFORMANCE OF A MODERN ADOBE HOME IN IN SOUTHERN CALIFORNIA

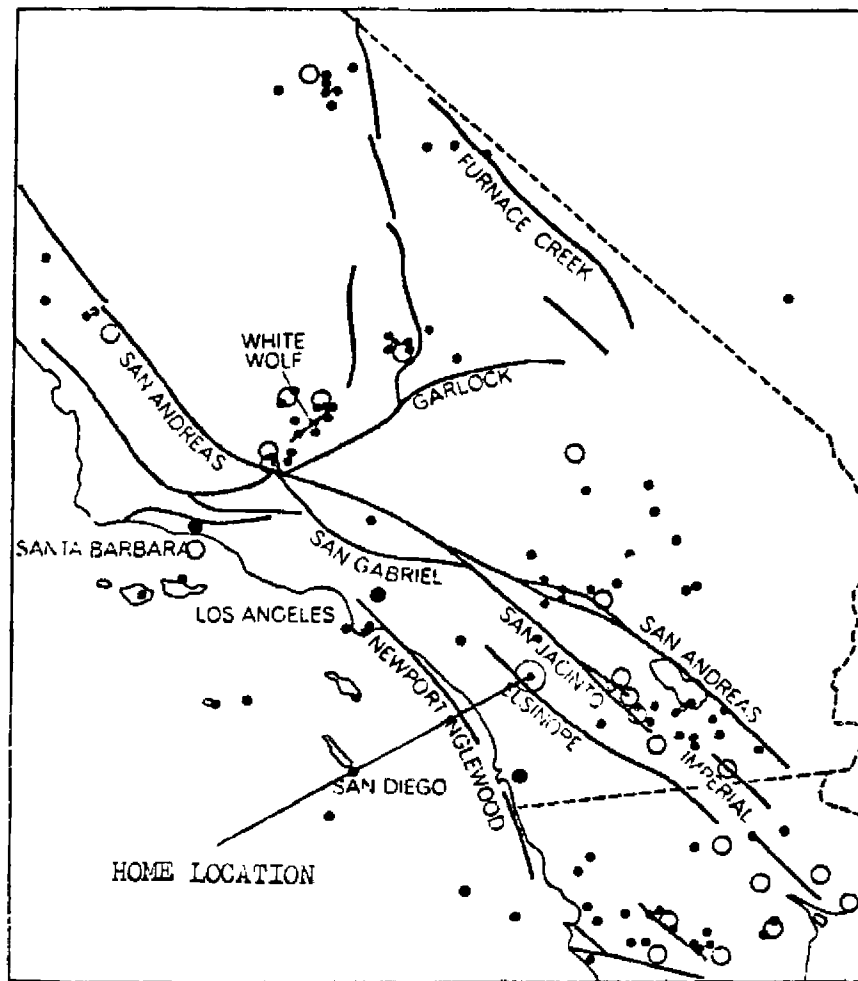
FIG. 8

Thirty-six year earthquake record shows the epicenters of all events of magnitude 5 or greater recorded in Southern California and in the northern part of Baja California from 1931 through 1969. The epicenter is the point on the earth's surface above the initial break. Dots show earthquakes between 5 and 5.9 in magnitude. Open circles indicate earthquakes of magnitude 6 or greater. The hypocenter, the point of the break in the earth's crust, is often many miles below the surface in thrust-type earthquakes, a type frequently observed in this region. In the 36-year period Southern California and adjacent regions experienced more than 7,300 earthquakes with a magnitude of 4 or more. Earthquakes are about 10 times more frequent in this area than they are in the world as a whole.

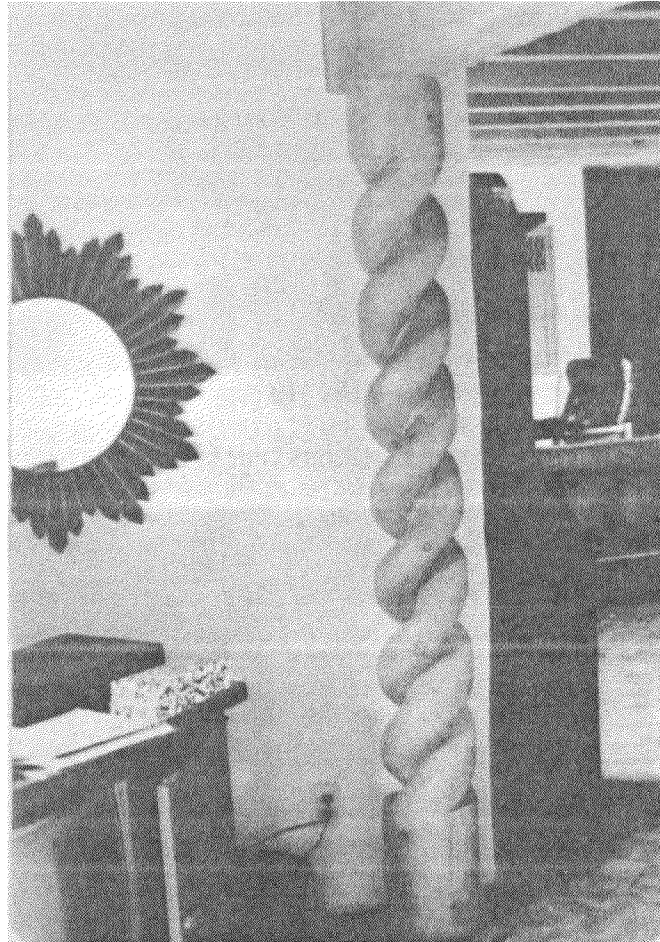
FIG. 9

Crooked Wall and Spiral Wood Column

Due to lack of tooling or precise workmanship, the Mexican-Indian adobe homes built near Mexico City were constructed with slightly crooked walls. Such wall crookedness was duplicated by Mr. Jakway in his adobe home shown in Fig. 9. The slight curvature in the walls provides an aesthetically appealing view without providing a sense of insecurity. All door and window frames were cut from hewed logs and set flush into the walls. The windows were constructed from iron bars and glass set into a soft lead sodder. Thus, the windows cannot be opened.
