UNCORRECTED ACCELEROGRAM FROM FREITAS BUILDING, SANTA BARBARA

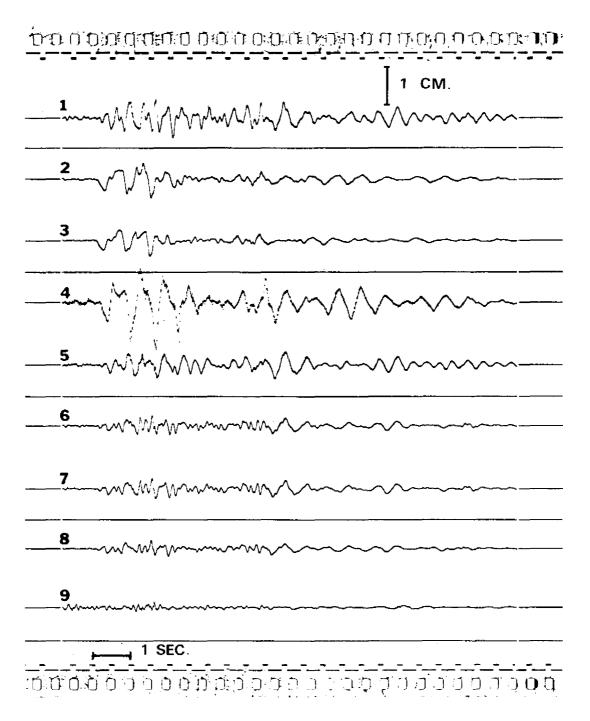
Fig. 3.8 Uncorrected Raw Accelerogram Recorded at Freitas Building, Santa Barbara. 1.8 cm $\stackrel{\sim}{=}$ lg. (Provided by Office of Strong Motion Studies, California Division of Mines and Geology.)

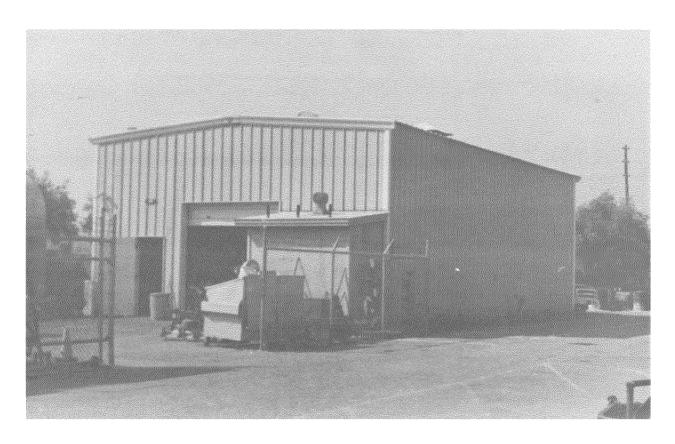
Fig. 3.9 Building 340, UCSB campus. (Location of Goleta Free Field instrument).

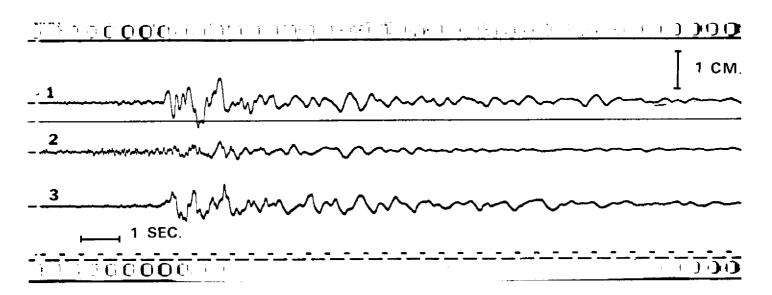
Fig. 3.10 Uncorrected Raw Accelerogram Recorded at Building 340, UCSB (Goleta Free-Field.) Traces 1 and 3 are horizontal and 2 is vertical. 1.8 cm $\stackrel{\sim}{=}$ 1g. (Provided by Office of Strong Motion Studies, California Division of Mines and Geology.)

The strong motion records recorded at Building 340 are shown in Fig. 3.10. Again it appears that the duration of strongest ground motion was approximately 2 to 3 seconds. The peak acceleration appears to be about 0.39g.
