# GUIDE TO DOCUMENTING EARTHQUAKE DAMAGE TO POWER SYSTEMS

Anshel J. Schiff

## ABSTRACT

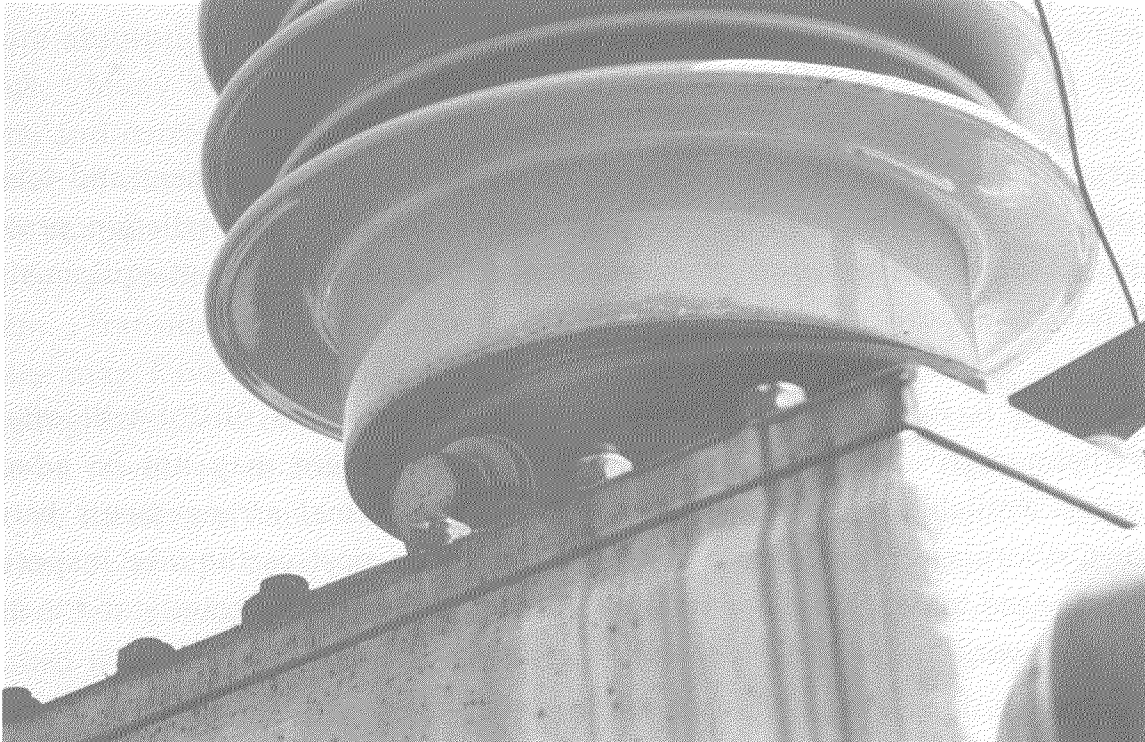
Fig. 1 Shifted Transformer Bushing

Transformers are one of the few items in a power system whose function cannot be eliminated or substituted. Bushings can crack and must be replaced. There can also be slipping or oil leaks at the interface between the porcelain and the metal flange that make up the bushing. Figure 1 illustrates an extreme example of bushing offset. This interface should be carefully observed for signs of oil leaks, small offsets, or gaskets protruding from the interface. Epoxy is often placed on the outside of the bushing - flange interface in an attempt to stop oil leaks.
