General Hospital, Grenada

In accordance with your instructions, we have carried out a Vulnerability Assessment of the Hospital at Fort St George in Grenada. The Assessment included field surveys, interviews with various members of the hospital staff and the Ministry of Health, and desk studies.

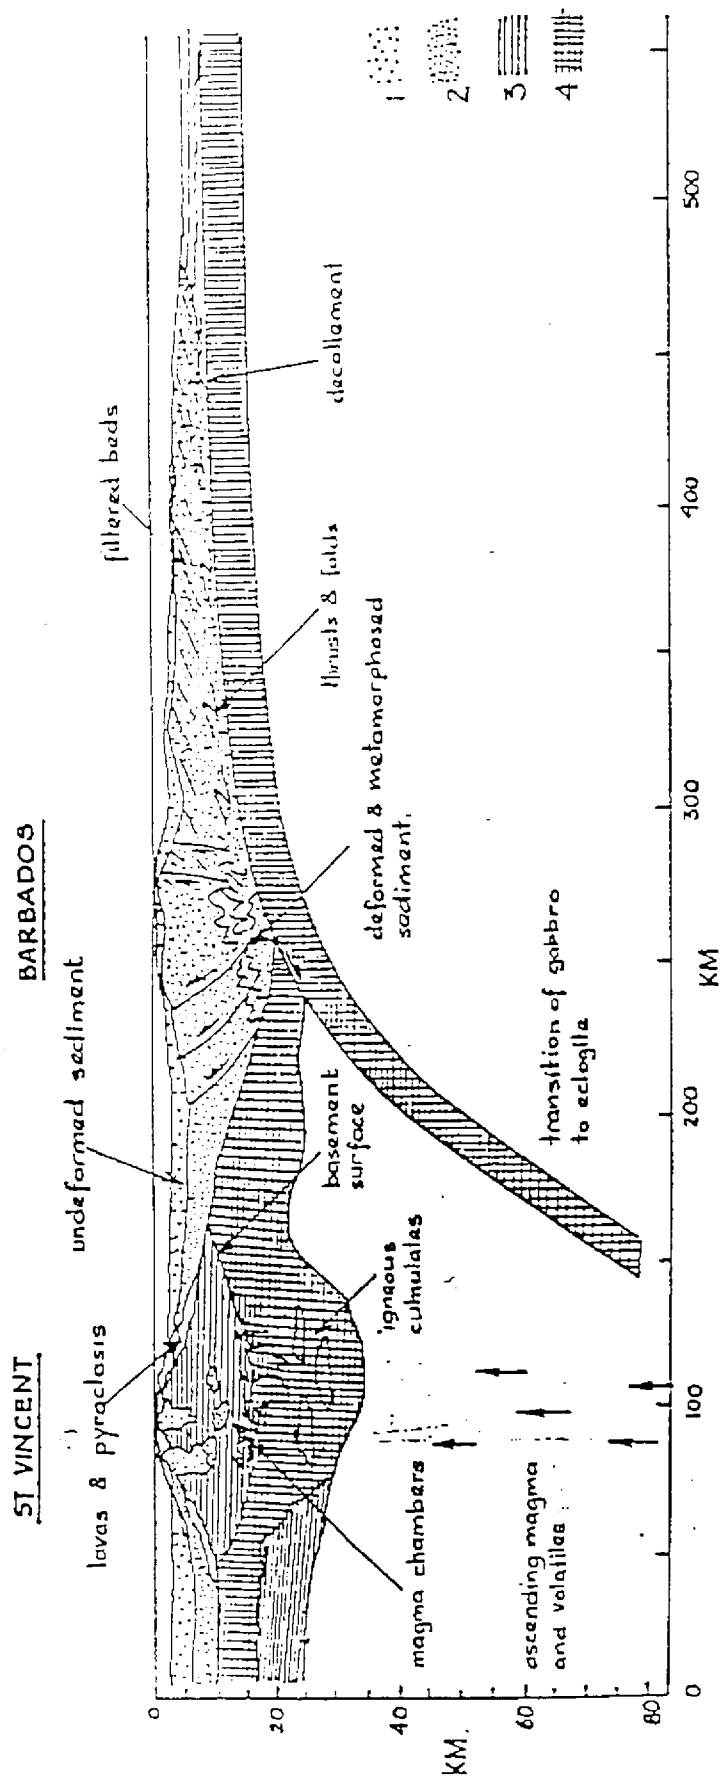
Figure 3

Diagrammatic cross-section of the Eastern Caribbean island arc illustrating the structure and the processes acting on it. 1. Undeformed sediment. 2. Deformed and/or consolidated sediment. 3. Igneous crust produced by the volcanic arc. 4. Main oceanic crustal layer and lower crust of arc. Vertical exaggeration 2:1.

Structure in Region of Barbados
(Westbrook, 1970)

Caribbean Plate and the Americas Plate. Figures 1, 2 and 3 (at the end of this sub-section) show the tectonic setting of the Caribbean, the main physical features of the Eastern Caribbean and a cross section through the island arc.
