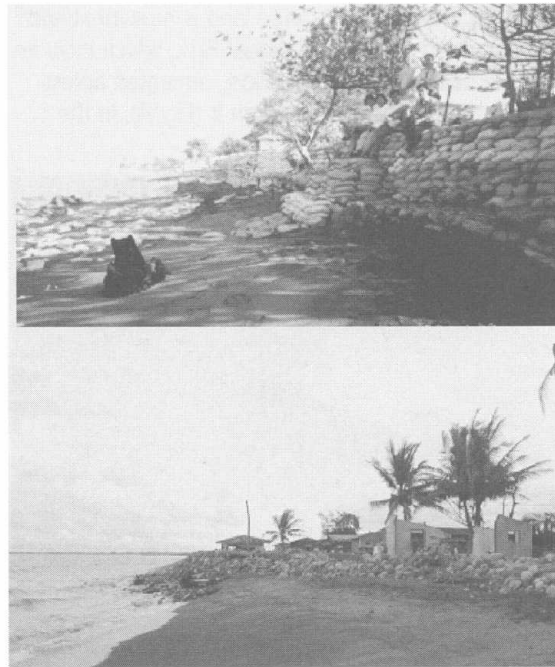
Figure 3. Cheaper alternatives to the more expensive coastal protection structures: sandbags in Wenceslao (top) and ripraps in Alaska (bottom). In the long run, however, maintaining these structures also becomes costly.

Individually or as a community, the people of La Union responded to the prevalent erosion either by temporarily evacuating, relocating, building ripraps or sandbags, or if funds are available, by constructing seawalls (Fig. 3). Short-term erosion that occurs during storms or typhoons prompts affected communities to temporarily evacuate to a safer place; nevertheless, when conditions return to normal and partial or full beach recovery occurs, residents go back and restore whatever is left of their properties. In a lot of cases, however, beach recovery does not happen and people are forced to relocate, usually just several meters inland. Relocating has become frequent for many, especially for those living in persistently eroding coastal segments. In the case of Pilar in Bauang, residents have transferred five times already since 1975. To protect properties and infrastructures from erosion, private individuals and some communities resorted to building structures like ripraps, sandbags and seawalls. The ripraps and sandbags, according to the locals, were not effective in preventing erosion and maintaining them became costly in the long run. Those who have more resources, such as along Carlatan in San Fernando, construct more robust structures.

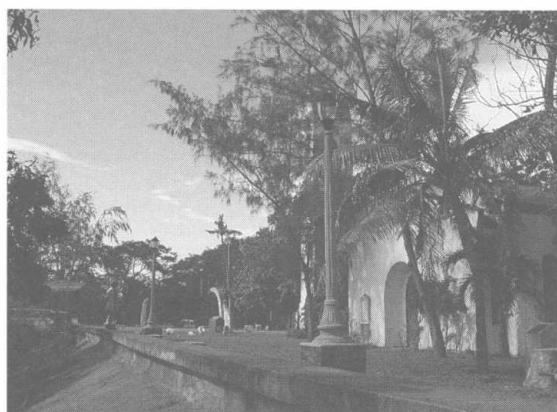
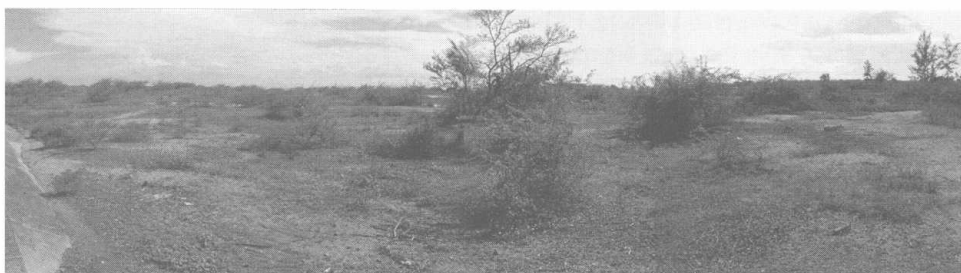
Figure 4. In 1980, a 1.5-km long seawall was constructed to protect communities and the Agoo-Damortis National Seashore Park in Sta. Rita (left). At present, however, approximately 450 m of land accreted in front of the structure (below) due to the natural southward drift of sediments coming from Aringay River, 5 km north of the area.

On the contrary, new coastal lands formed by progradation are promptly occupied and even titled, though by law it should be public land (Commonwealth Act 141, Chapter IX). In Sta. Rita Central, Aringay, shoreline prograded by approximately 350 m from 1940s to 1970s. This newly-accreted land is now inhabited and the Agoo-Damortis National Park, which includes a basketball court, church, resort, cemented access road and the seawall, is built on it (Fig. 4). In the

past 30 years, another 450 m of land was added to this coastal stretch and is also being slowly occupied (Fig. 4). This prompt occupation of newly-formed land leads to a lot of problems later on: in Caba, for example, progradation in the late 1930s until 1960s lured people to settle in, but were later forced to relocate several times because of the subsequent erosion that took place (Siringan and Jaraula, 2002). This led to loss of properties. Thus, the local government should be prompt in declaring accreted land as public property to avoid a similar scenario.

In contrast to the large shoreline retreat that occurred in Alaska, the coastal stretch to the south, in Dulao and Sta. Rita, experienced rapid land accretion after the earthquake (Fig. 4). These areas are at the receiving end of the eroded materials from Alaska and the sudden influx of sediments from the rivers due to earthquake-induced mass wasting in the upstream. Rapid progradation south of the Bauang River is ascribed to the southward migration of the river mouth coupled with the south-directed longshore currents. However, because these lands are relatively new, they are also likely to experience liquefaction in the future. Furthermore, because these segments are very close to the river, future shifts in river course may lead to rapid erosion. The northern flanks of the deltas, although seemingly "stable" at

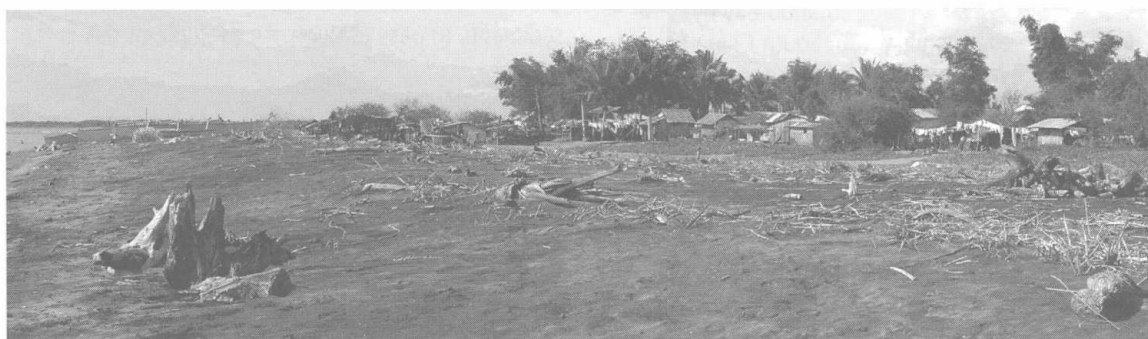
Figure 5. Present shoreline of Barangay Alaska is littered with tree stumps indicating that trees used to thrive along the coast. During the July 1990 earthquake, a large area of Alaska subsided by 1 to 2 m as a result of liquefaction. According to the locals, prior to the earthquake, the shoreline was approximately 1 km farther offshore.

In July 16, 1990, a 7.8-magnitude earthquake rocked central Luzon. This devastating earthquake caused several areas in La Union, specifically along the coasts of Aringay, Agoo and Sto. Tomas to subside instantaneously due to liquefaction: 1 to 2 m in Alaska (anecdotal account), 0.5 m in San Nicolas West, 1 to 2 m in Cabaroan, 1 to 3 m in Narvacan (Geomatrix, 1995), among others. Widespread inundation accompanied the lowering of coastal lands; the most severely-affected area is Alaska, wherein residents recounted about 1 km of sea encroachment (Fig. 5). After the earthquake, the locals in Sto. Tomas observed slight shoreline progradation; but because the land is now lower, it became more prone to erosion. Torres et al. (1994) attributes liquefaction in La Union and in the neighboring provinces to the nature of the underlying material: relatively unconsolidated and water-saturated sands. Aringay sits on a delta, which is built by rapid and continuous deposition of materials from Aringay River. Agoo and Sto. Tomas, are atop very young sandy deposits formed by accumulation of sediments transported by the longshore current.
