CONSTRUCTION SPECIFICATIONS OF STRUCTURES TESTED ON THE IMPULSE TABLE

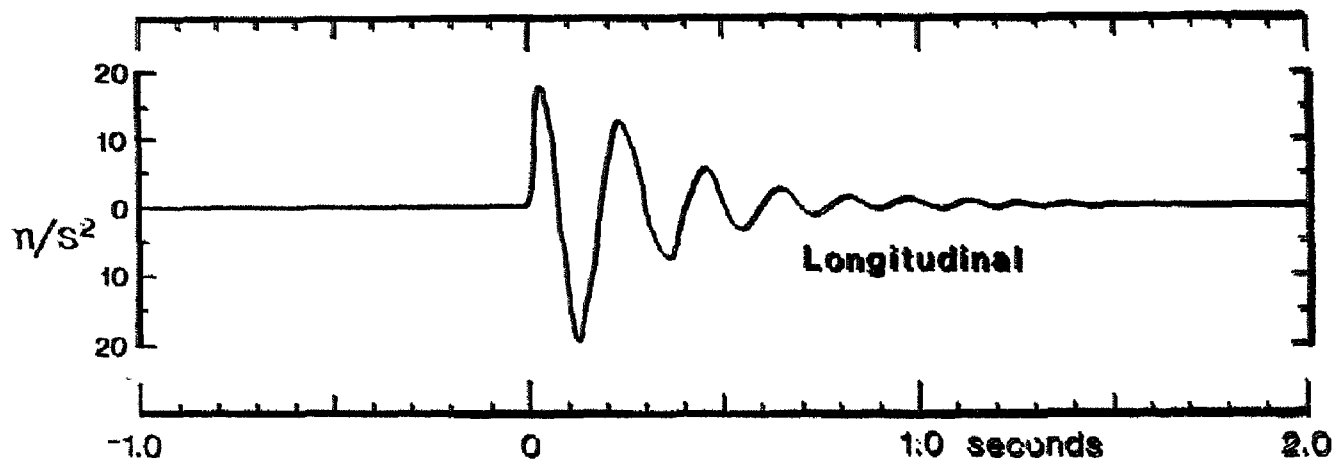
Figure 4.4 Impulse Table: Longitudinal Acceleration of a Single Pulse

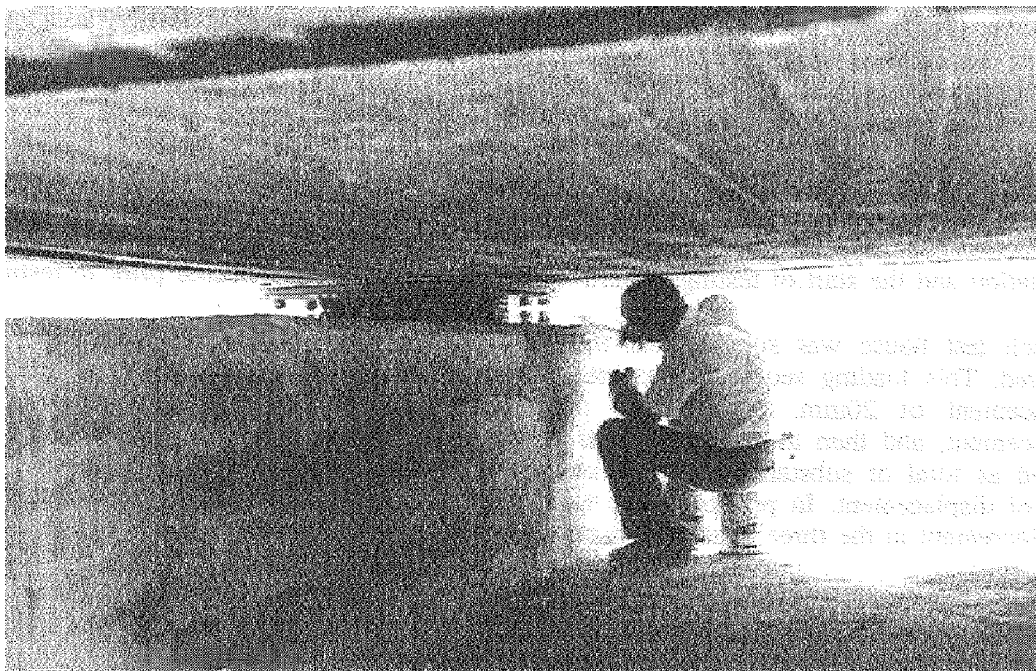
Figure 4.5 Impulse Table: Bearing Assembly

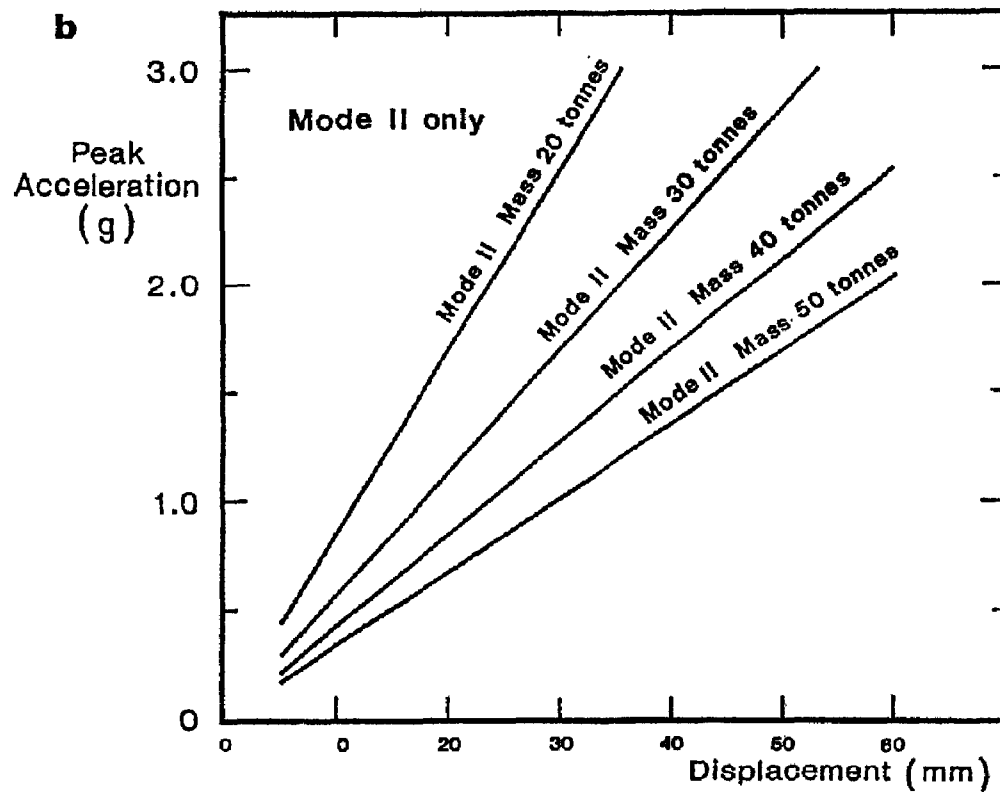
Figure 4.6 Impulse Table: Operating Characteristics

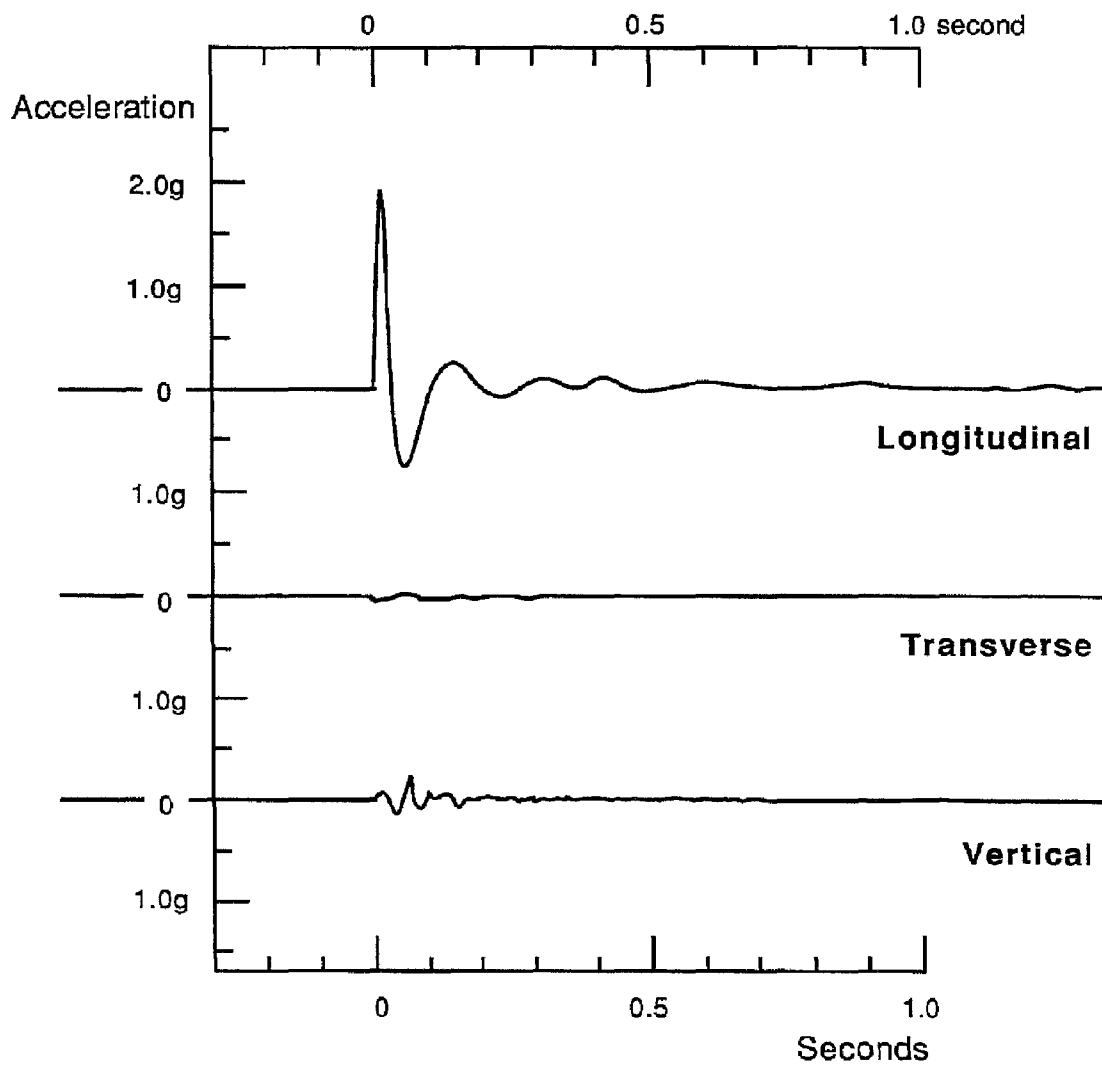
Figure 4.12 Impulse Table Tests: Typical Accelerometer Readings

typical set of accelerometer readings is shown in figure 4.12. The peak acceleration in each pulse for each of the three tests is given in table 4.2.

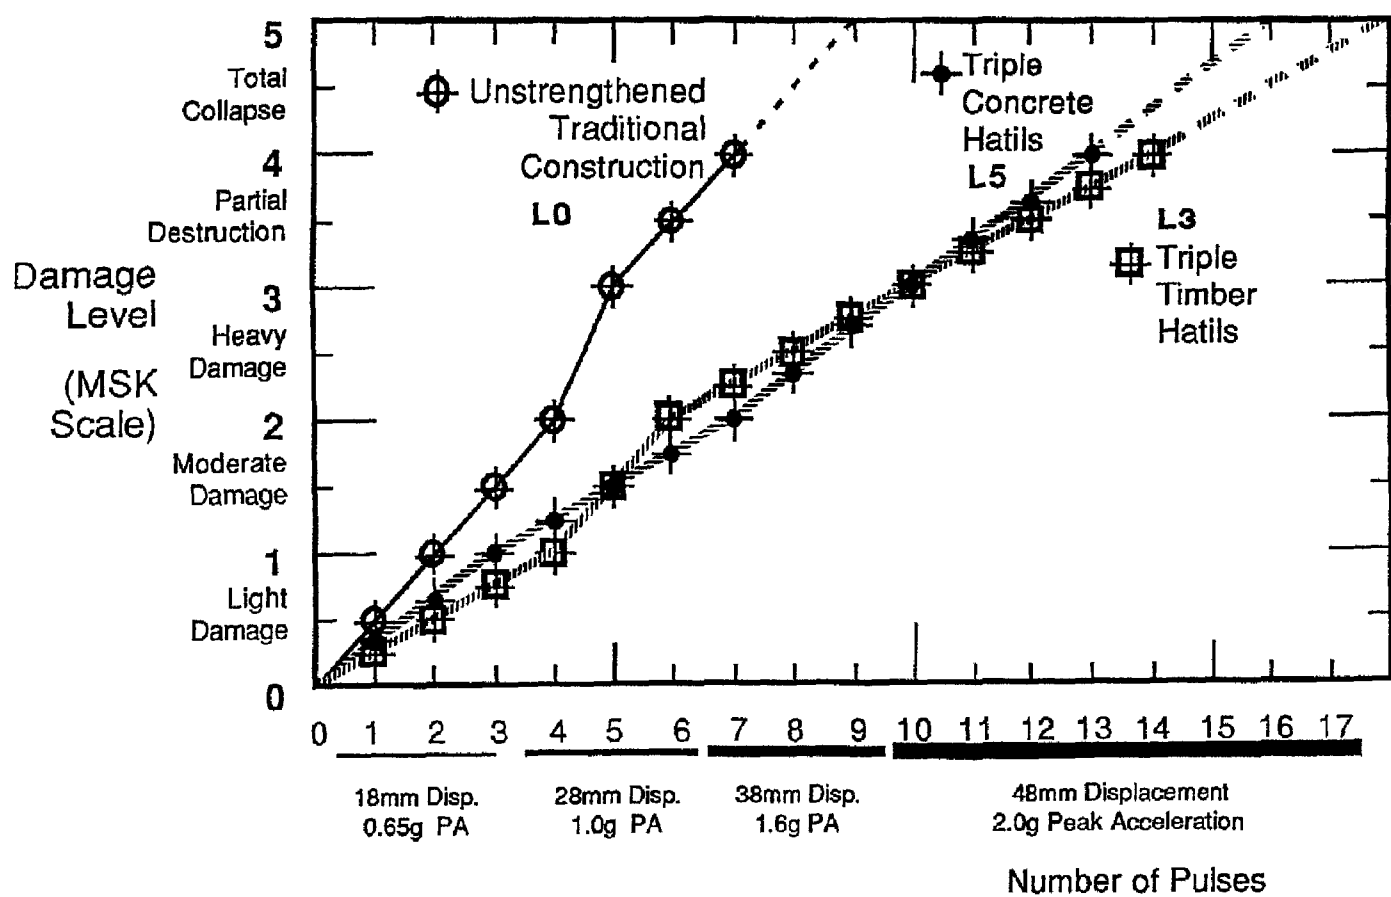
Figure 4.14 Impulse Table Tests: Comparative Performance of Test Structures

One way to compare the performance of the three test structures is by the level of damage caused by the same degree of shaking. Since all test structures experienced approximately the same sequence of pulses, the number of pulses experienced can be used as a crude measure of shaking severity. The level of damage can be assessed using the damage levels 0-5 defined in the MSK scale⁶ and each damage level can be further subdivided according to the number of pulses in which it was recorded. Table 4.2 shows the damage level assessed after each pulse, and the comparison between the three tests is shown in figure 4.14.

Two observations can be made from figure 4.14. The first is that the two reinforced structures behaved in a very similar manner up to the point at which Test 2 was terminated. The much more disintegrated state of the walls of the third test house at the end of the test was solely due to the fact that it experienced five further pulses than Test 2. The second observation is that it shows very clearly the strengthening effect of the reinforcement. At pulse 4, the unreinforced structure experienced heavy damage, while the reinforced structures experienced only light damage; at pulse 5, the unreinforced structure experienced partial collapse, while the reinforced structures experienced moderate damage; and at pulse 7, when the partial collapse of the unreinforced structure took place, the reinforced structures were just at the onset of heavy damage.
