Landsliding and Flooding

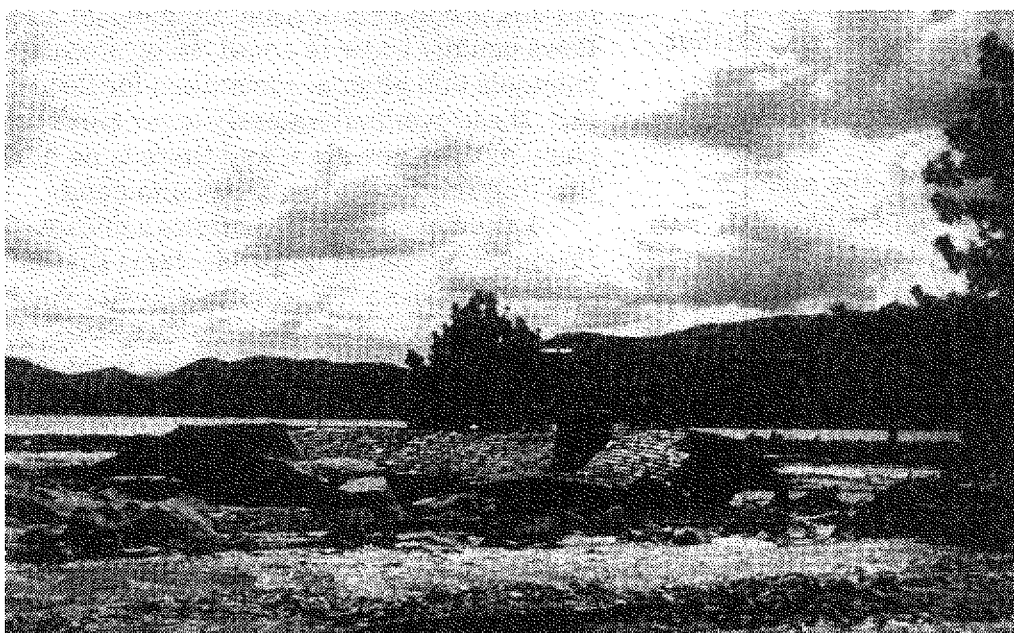
Figure 17.
*House destroyed by
1983 Slide Mountain,
Nevada landslide
(photograph by
Robert J. Watters,
University of
Nevada, Reno).*

In 1983 a large mass of rock detached from Slide Mountain in Nevada. The mass slid into Upper Price Lake, an irrigation reservoir, displacing most of the water which overtopped and breached the dam, flowing into Lower Price Lake. This lake's dam was also breached. The water flowed into Ophir Creek where it collected large amounts of debris and became a debris

flow. After traveling about four kilometers and dropping 600 meters in elevation, the debris flow emerged from the canyon onto the alluvial fan of Ophir Creek (total time—15 minutes). One person was killed, four injured, and numerous houses and vehicles were destroyed (Figure 17) (Watters, 1988).
