FIGURE 6-11 East-West Ground Displacement Time History At Tlahuac - 1985 Michoacan Earthquake

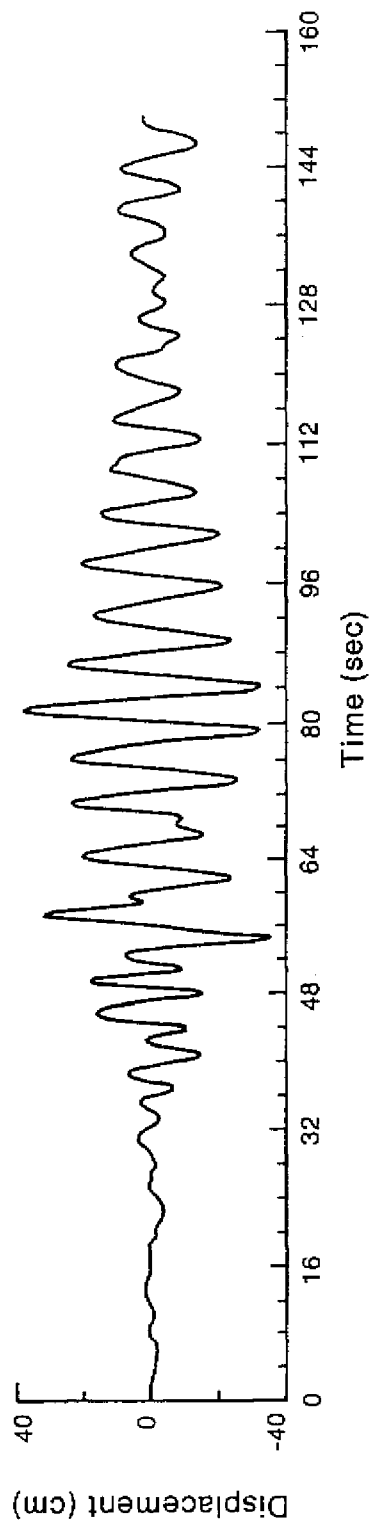
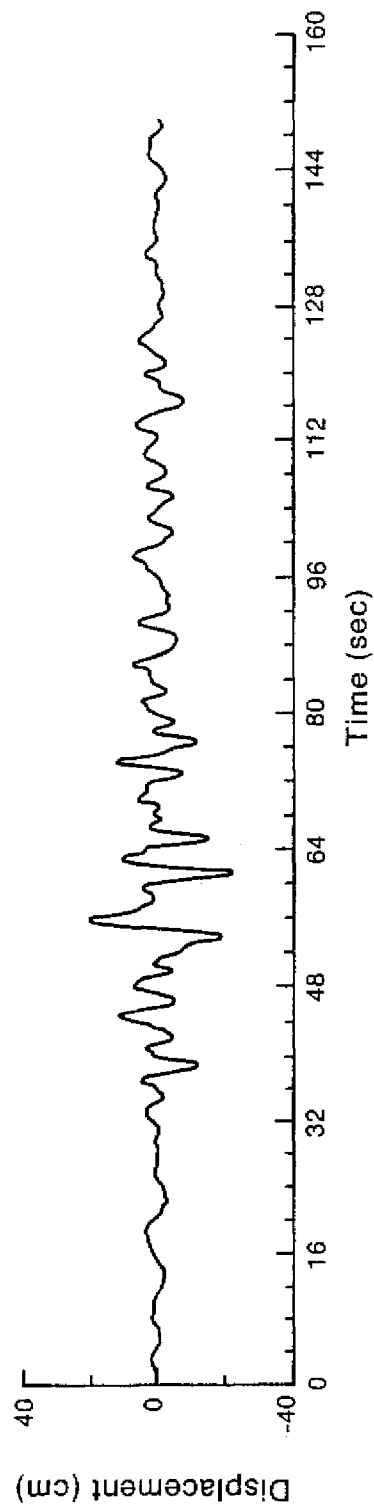
a) Tlahuac Bombas (TLHB)

b) Tlahuac Deportivo (TLHD)

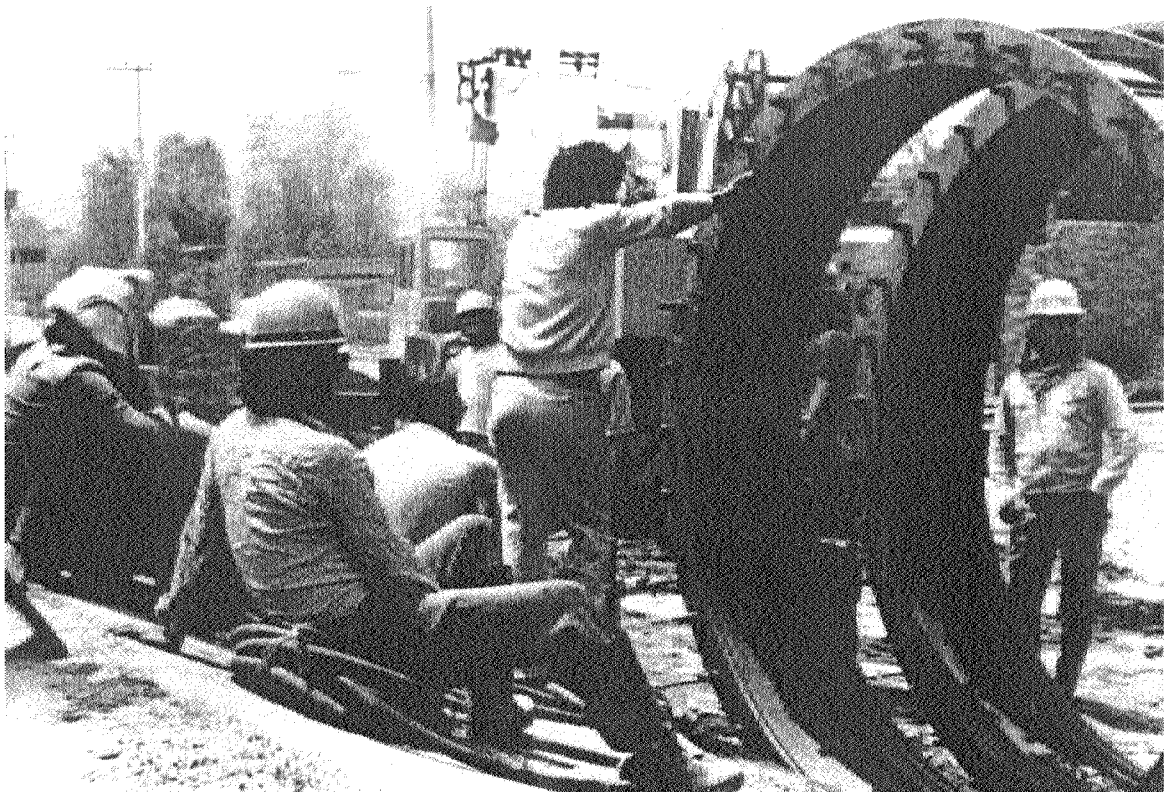
FIGURE 6-12 View Of A Steel Repair Saddle
