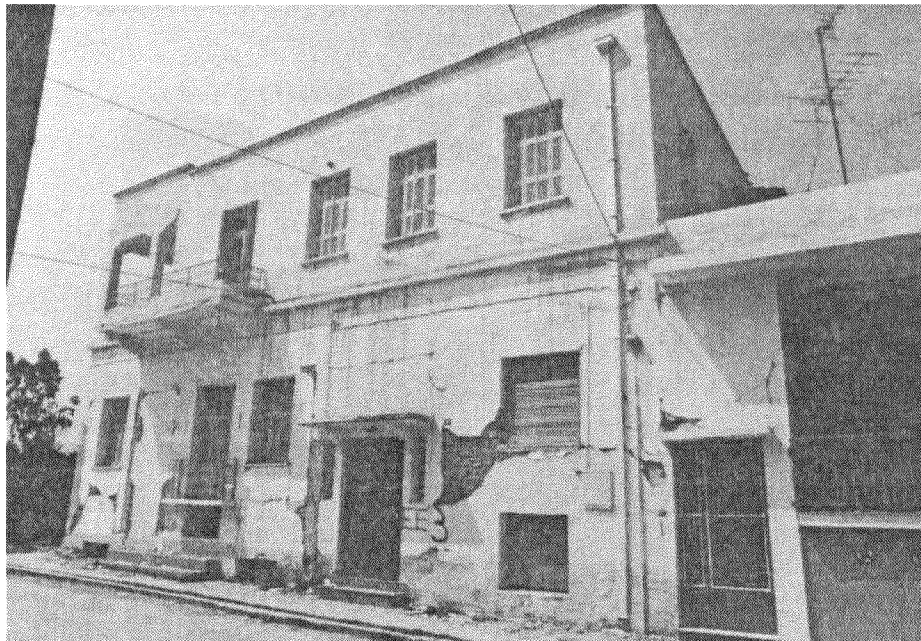
FIG. 11

An one storey old earthen building has been renovated with the addition of R/C columns and R/C beams, and of a second storey, out of R/C load carrying system and baked brick walls for partitions.

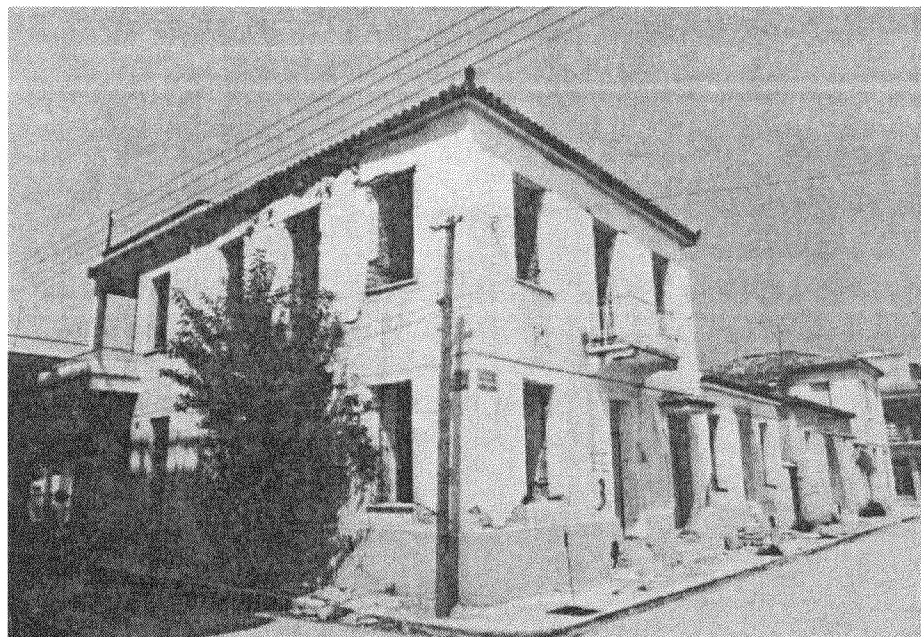
FIG. 12

A modern construction out of R/C and baked brick walls is added to an old two storied earthen building.
