**Lessons Learned From the Loma Prieta Earthquake of October 17, 1989.** In judging the lessons taught by this EQ, it should be kept in mind that it was a  $M_S=7.1$  EQ whose epicenter was nearly 100 km from San Francisco and Oakland. The EQGMs that have been recorded can be considered a moderate diagnostic test for structures located in these cities: bigger and more devastating EQs are certain to come to the Bay Area.

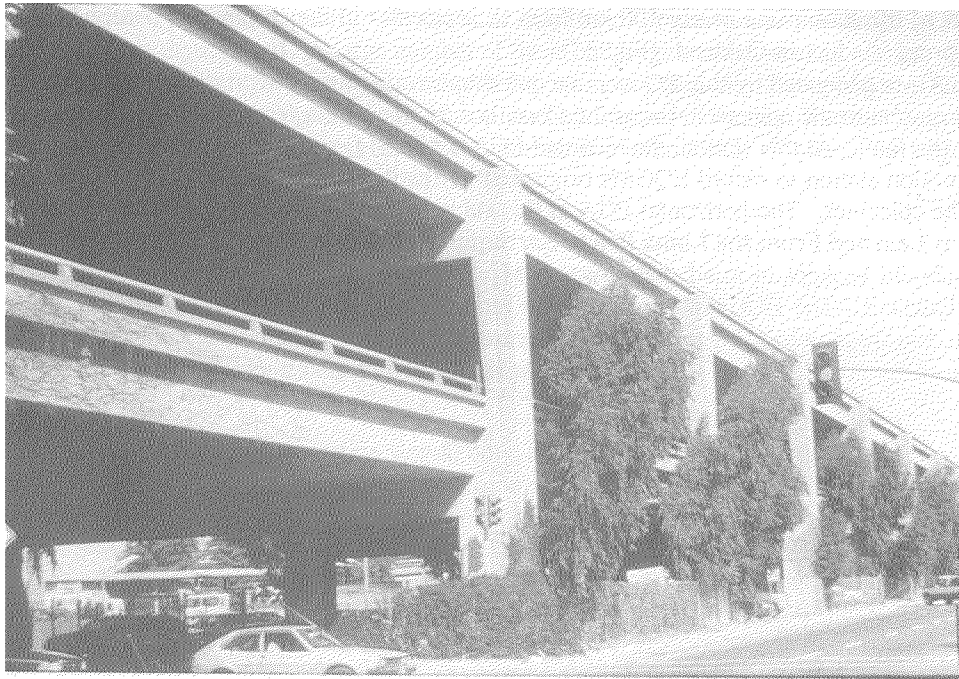
**Fig. 33 (a) The part that survived the EQ**

**Fig. 33 CYPRESS STREET DOUBLE-DECK VIADUCT: (a) THE PART THAT SURVIVED THE LOMA PRIETA EQ; (b) THE PART THAT COLLAPSED**

alone that have been estimated to exceed \$8 billion. Although the number of people killed was surprisingly low, the greatest loss of life took place nearly 100 km from the epicenter in the collapse of nearly 1.5 km of the upper deck of the Cypress Viaduct in Oakland (Fig. 33).

6. There was a large amount of damage to the transportation system, which resulted in the closure of several main highways and roads. This damage included the dramatic collapse of the Interstate 880 Cypress Street double-deck viaduct and of a section of the Bay Bridge and the serious damage to other overpasses and bridges.

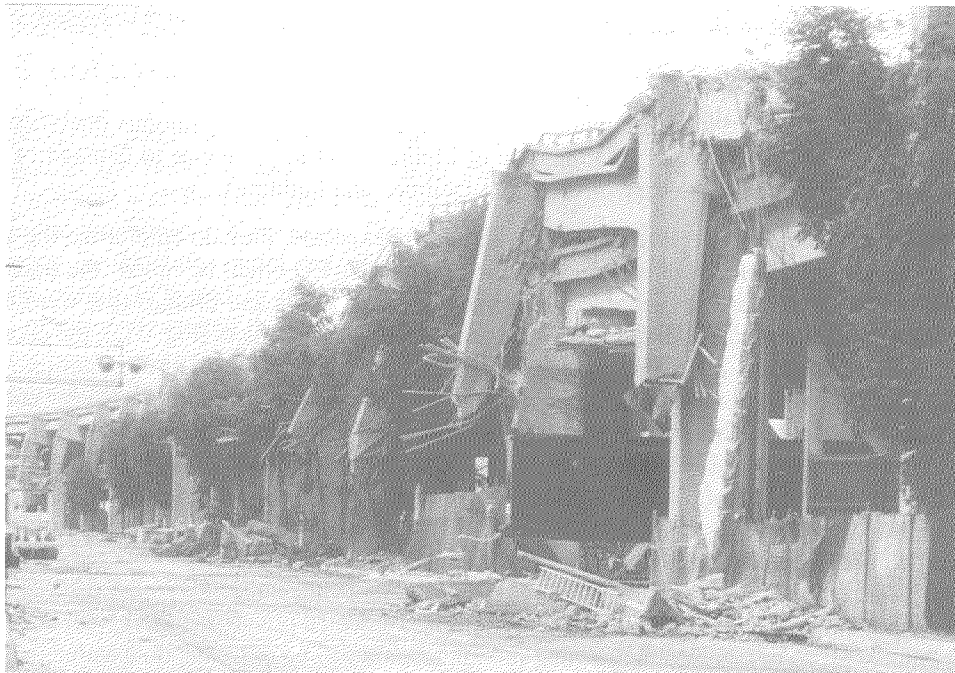
**Fig 33 (b) The part that collapsed**
