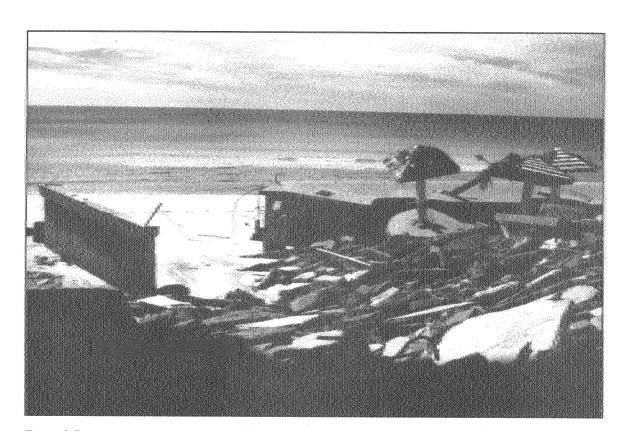
Figure 2-5 Debris, consisting of broken concrete and wood framing systems, generated by surge action

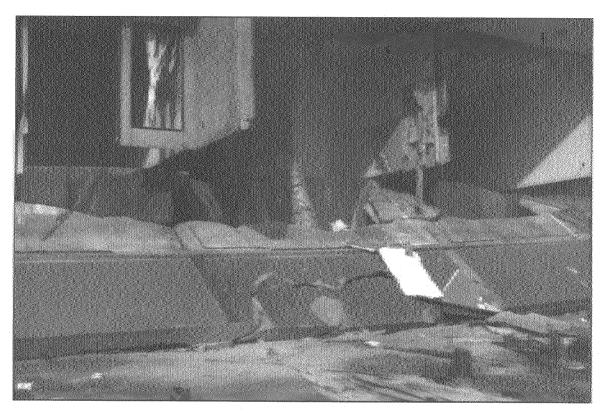
Figure 2-6 Undermining of concrete decks and floor slabs caused the failure of many unreinforced concrete structures.
