3 Recommendations

3.1 APPLICATION OF V-ZONE AND A-ZONE DESIGN AND CONSTRUCTION REQUIREMENTS

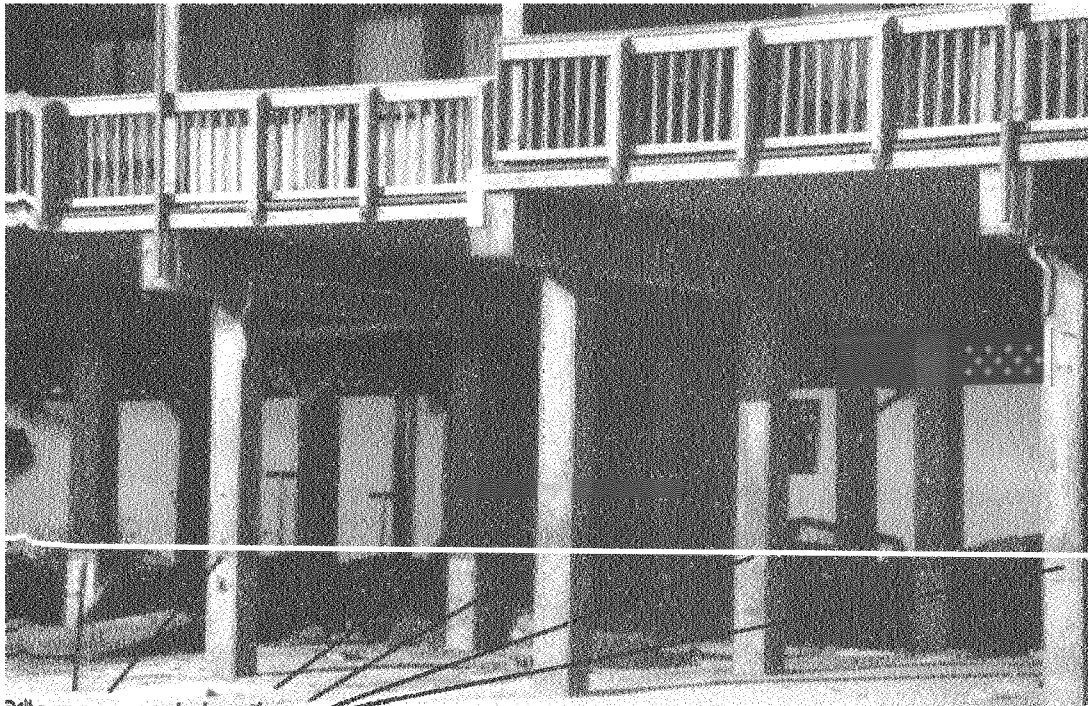
Figure 3-1 This well-constructed concrete structure survived the storm with little or no damage, even with 5 feet of erosion.

measures should be used to prevent sand or earth from collapsing into the excavation and reducing the pier cross-section. Figure 3-1 shows the survival of a structure built on a well-constructed concrete pile foundation that sustained severe erosion. Figures 3-2 through 3-9 show recommended pile, post, column, and pier foundation designs. While there were no failures observed of spliced wood piles (see Figure 2-8), the recommended practice is to install foundation elements in a continuous length (i.e., in one piece).
