Recommendations

9.1 General Recommendations

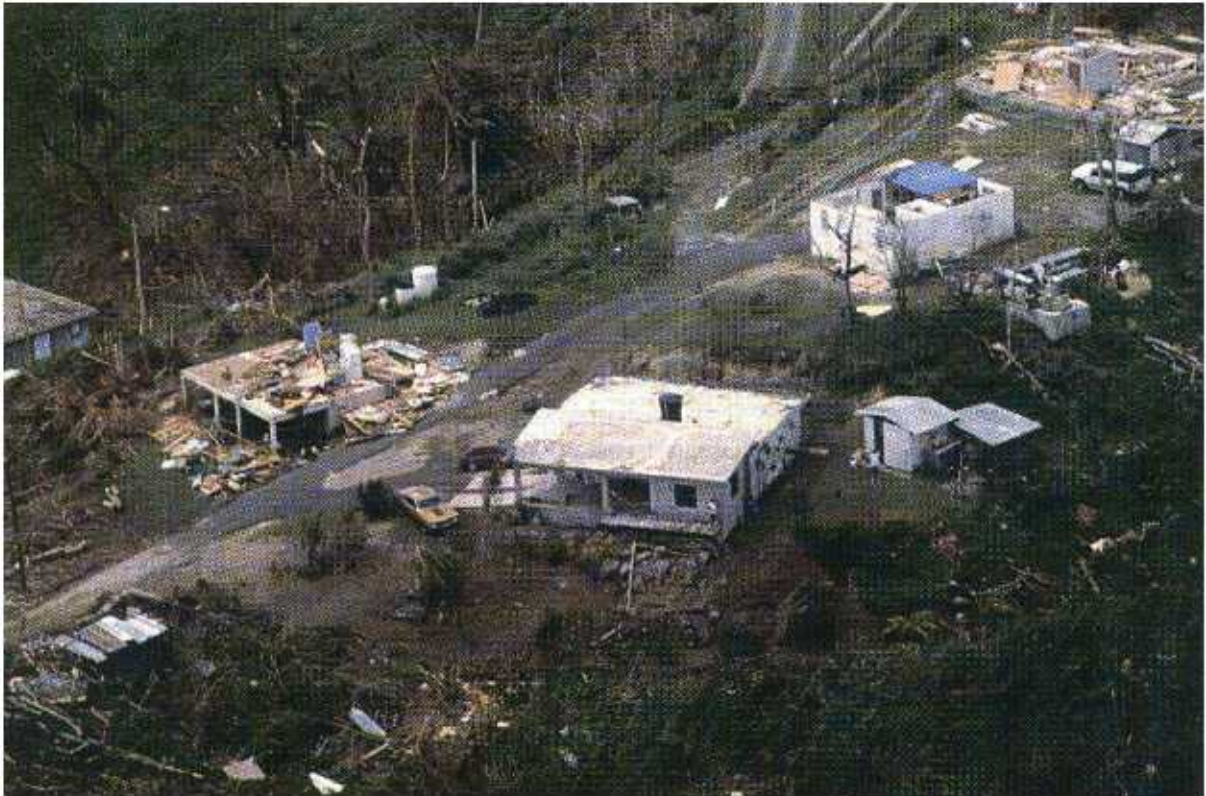
FIGURE 9-1 This photograph illustrates successes and failures in residential buildings observed after Hurricane Georges. A residential concrete building with no structural damage is seen in the center of the picture. At top right is a wood-frame building that is completely destroyed around a center room that was constructed of masonry. Other buildings in the photograph have damage that ranges from the total loss of the wood-frame building to the success of the concrete building.
