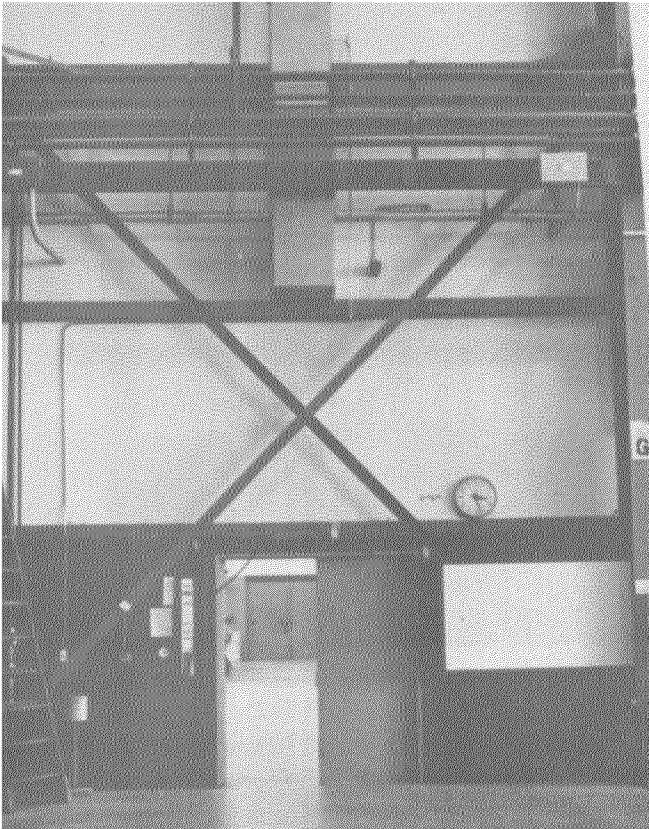
Figure 7.64 Diagonal bracing steel along east-west wall of large hanger at facilities of Aero Spacelines, Inc.

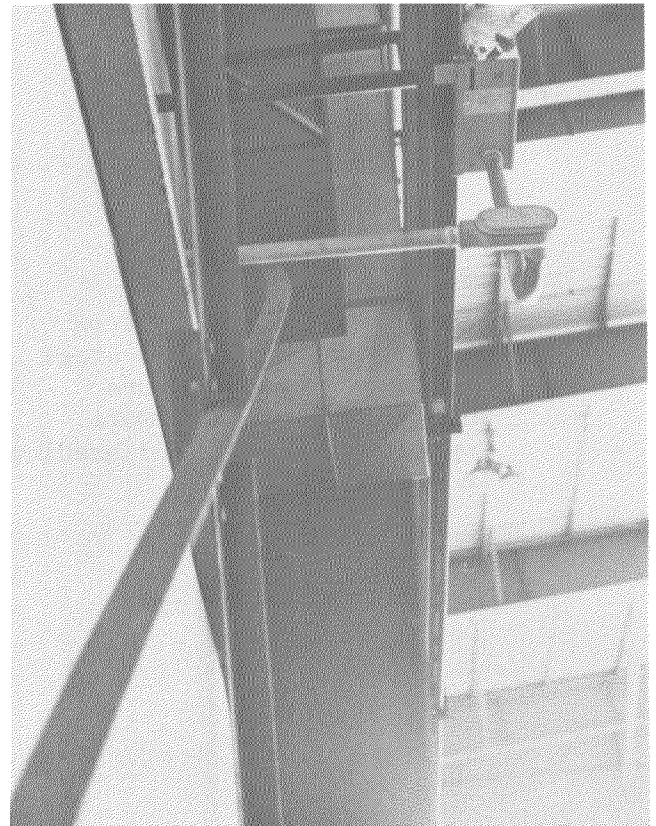
Figure 7.65 Buckling of diagonal bracing steel shown in Fig. 7.64
