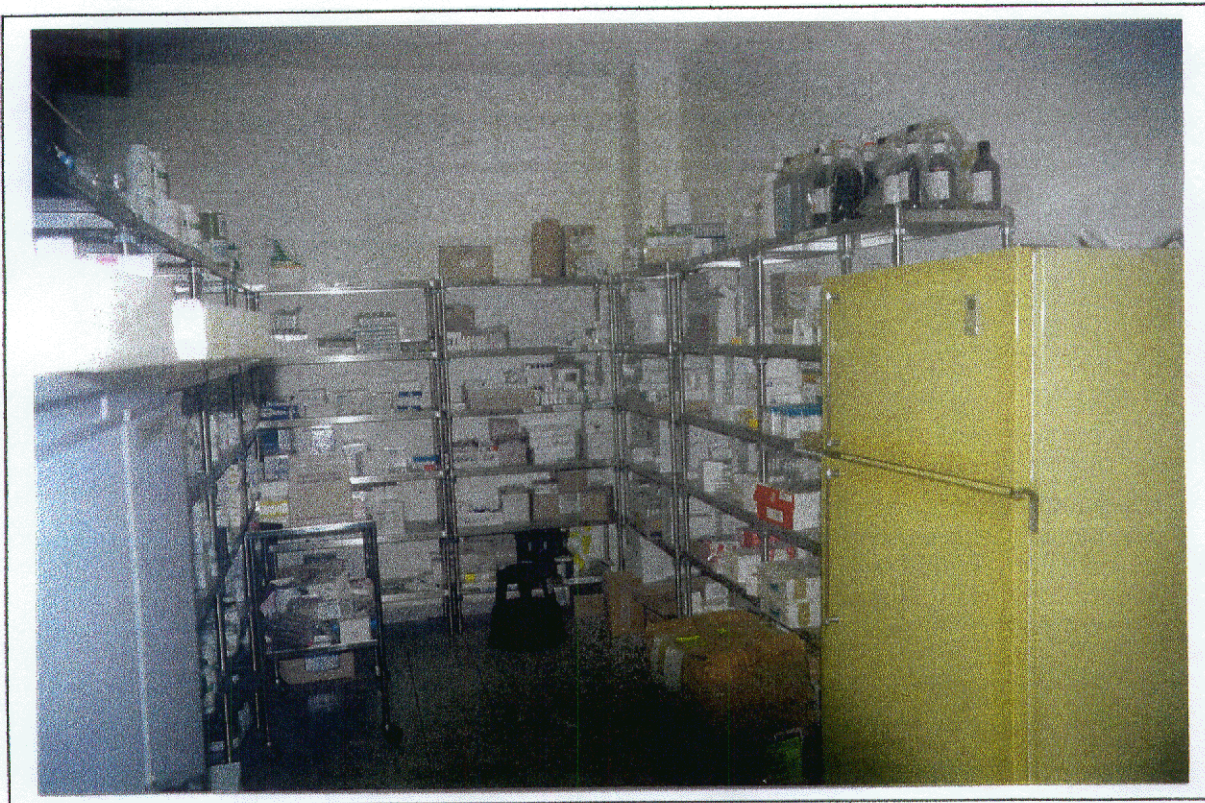
Photo 15 - The storage room of the Laboratory
 Note the trolley with wheels but without brakes.
 This could lead to accidents in earthquakes.

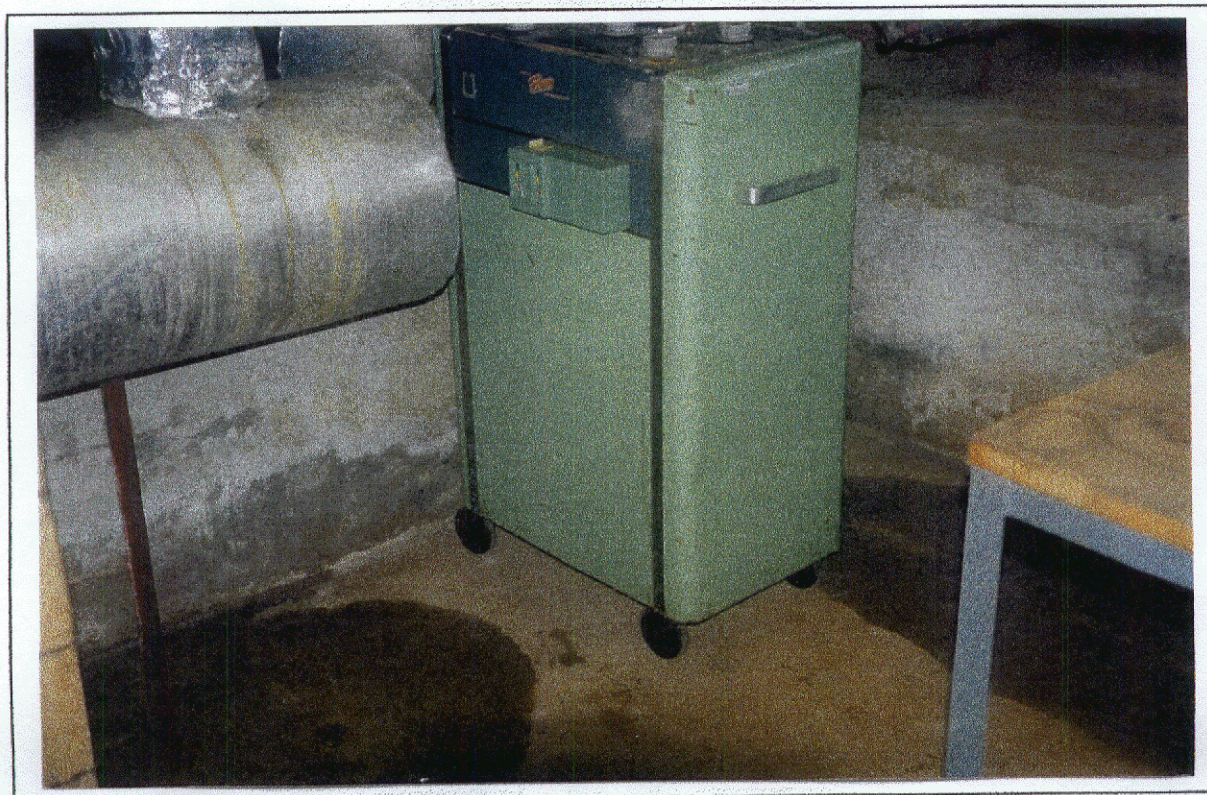
Photo 16 - The Utilities Block
 Note the equipment on wheels but without brakes.
 This could lead to accidents in earthquakes.
