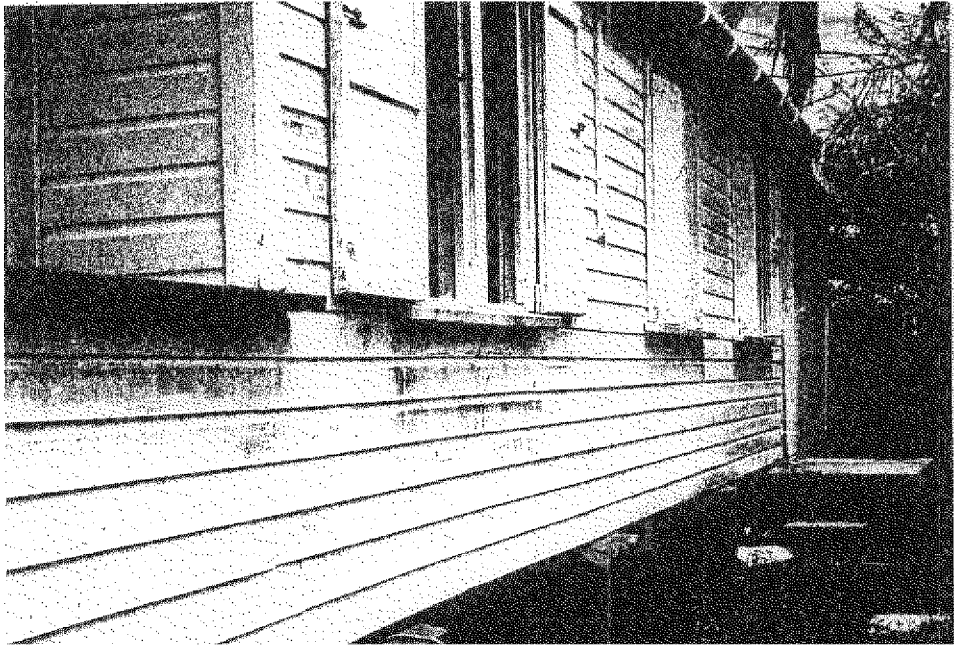
Piggots - traditional timber house well-provided with shutters.

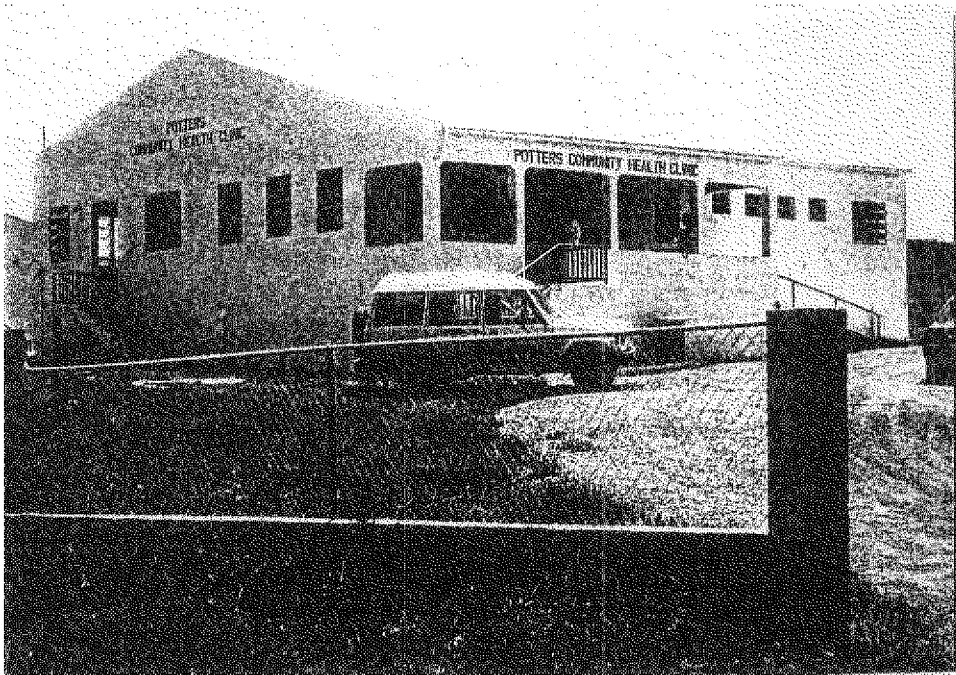
Potters - undamaged clinic.

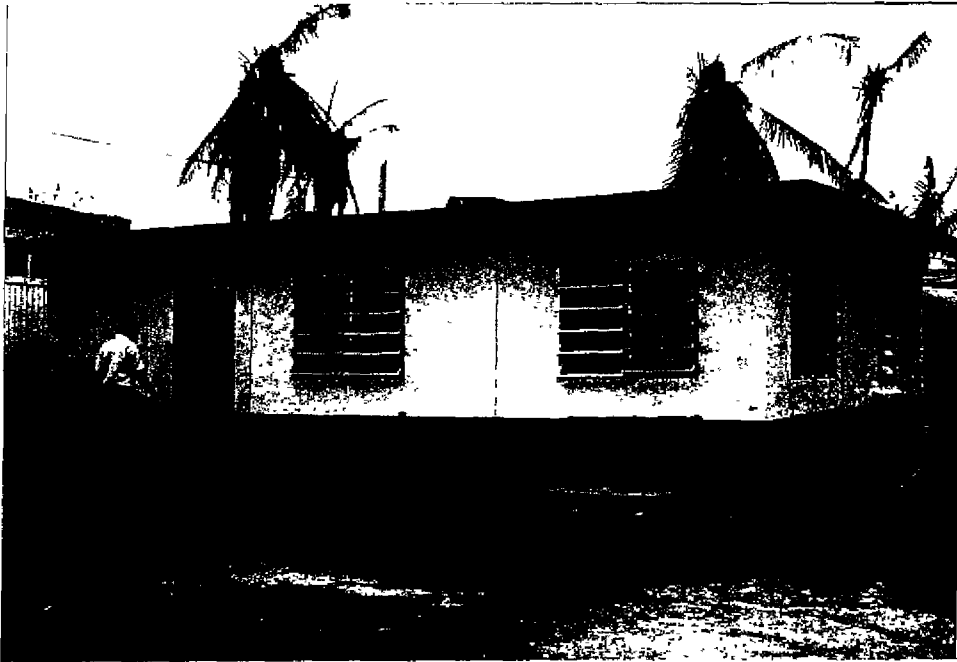
- Flood waters entered through a crack in the wall to the toilet and through the breeze blocks
- Door flew open during Luis allowing in water

- Concrete frame and roof slab
- No structural damage

Parham - undamaged clinic with reinforced concrete roof.

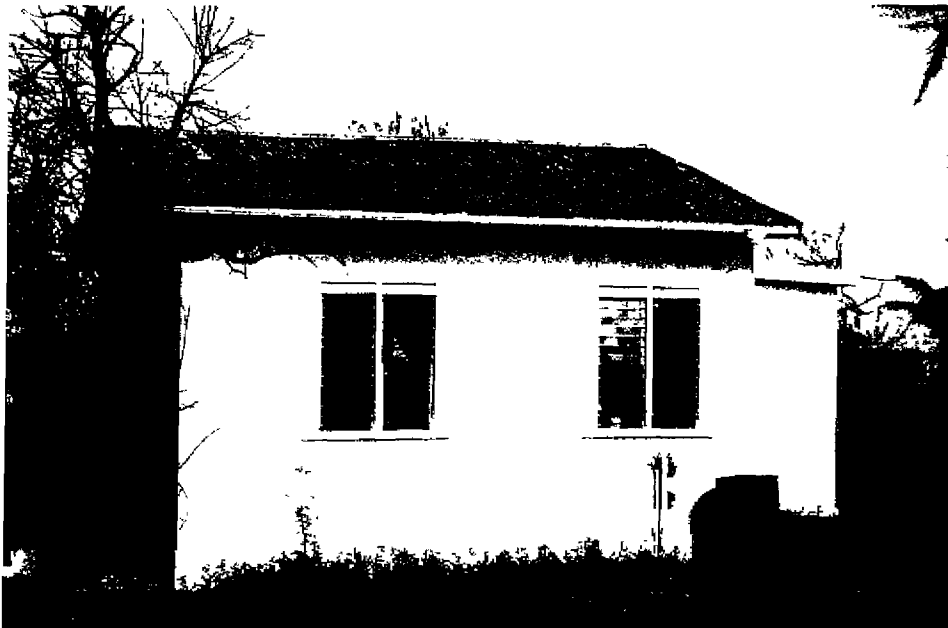
- Ingress of storm water

- There were broken windows before Luis
- There were recent roof repairs (before Luis) as evidenced by the different colour sheets.

Pares - recent repairs were done to the roof.
