2.14 Cedar Grove Clinic

2.15 Bishopgate Street Clinic

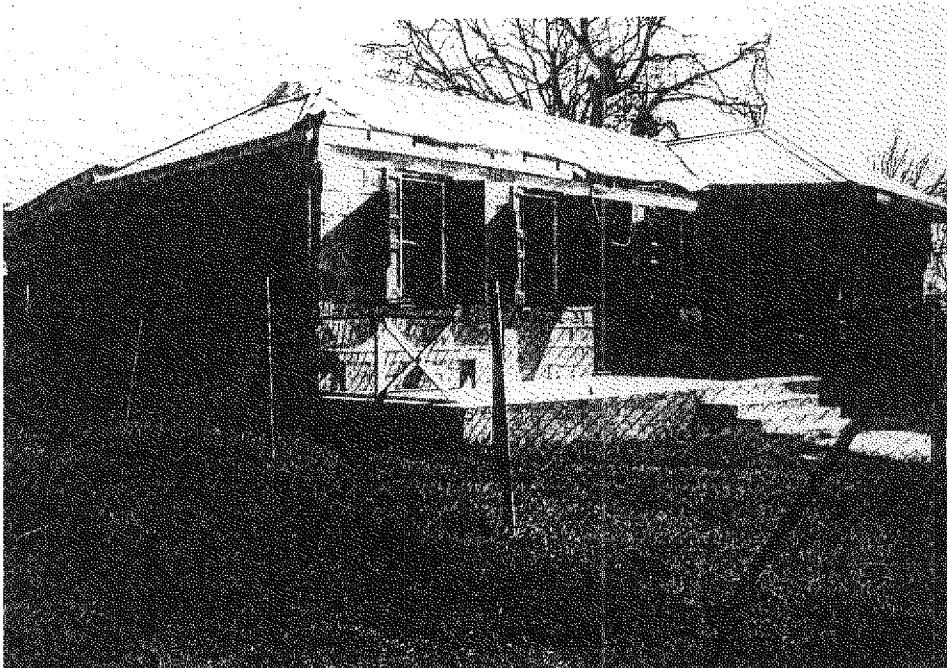
- The roof sheeting over the creche was lost, but the close-boarded ceiling remained intact.
- The entire roof over the balcony was lost.
- 2 doors cannot close because of warping and swelling.
- The plumbing leading to the water storage tank was broken but, in any case, the water storage tank "belongs to the people"
- Damage to ring beam

- Cedar Grove - complete removal of balcony roof.

- The main roof structure fared well. It was well built a long time ago with much attention to detailing. The more-recent additions caused most of the problems.

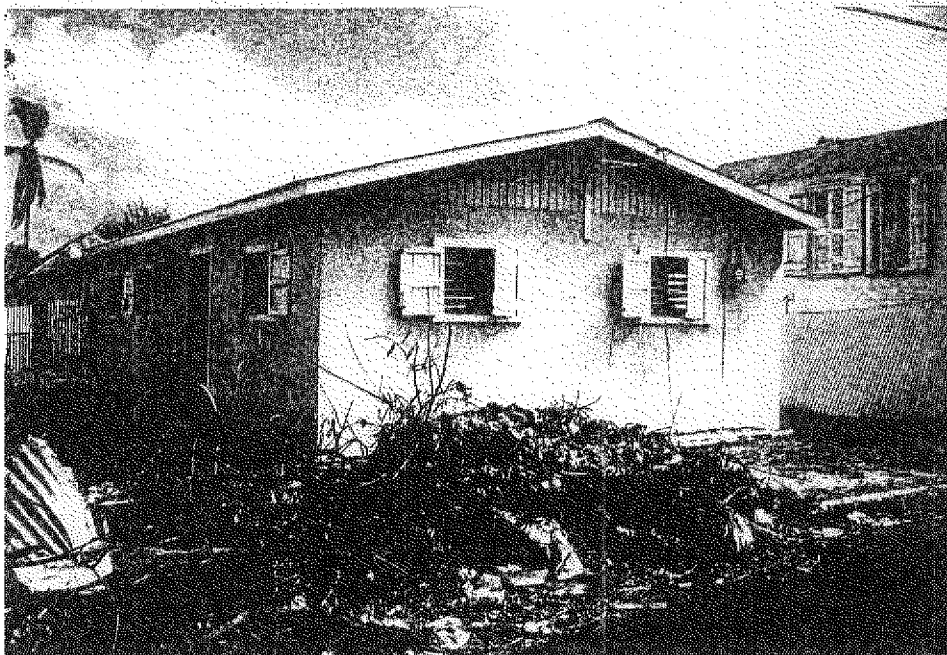
- No noticeable damage from Luis and no water came into the building.
- The building was provided with hurricane shutters (some clips were missing) and it has aluminum louvers.
- There were many cracks in the walls but these preceded Luis.

Bishopgate - note integral hurricane shutters.

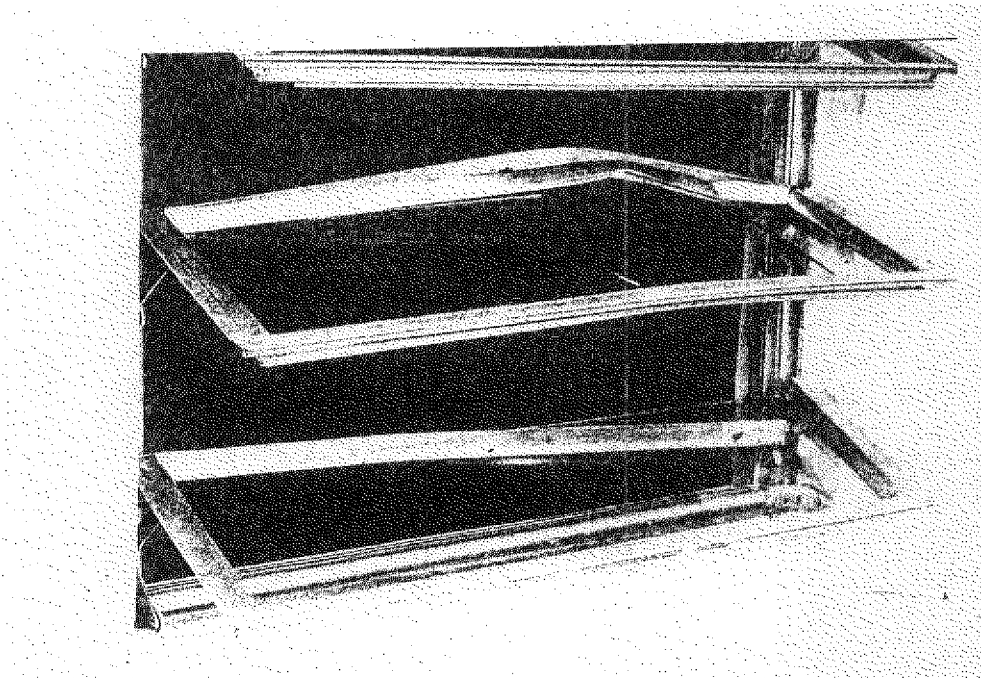
- There are three broken panes in the awning windows which are not, in any case, working properly.
- Some awning window frames were damaged by flying objects.

• Grays Farm II - impact damage to windows.

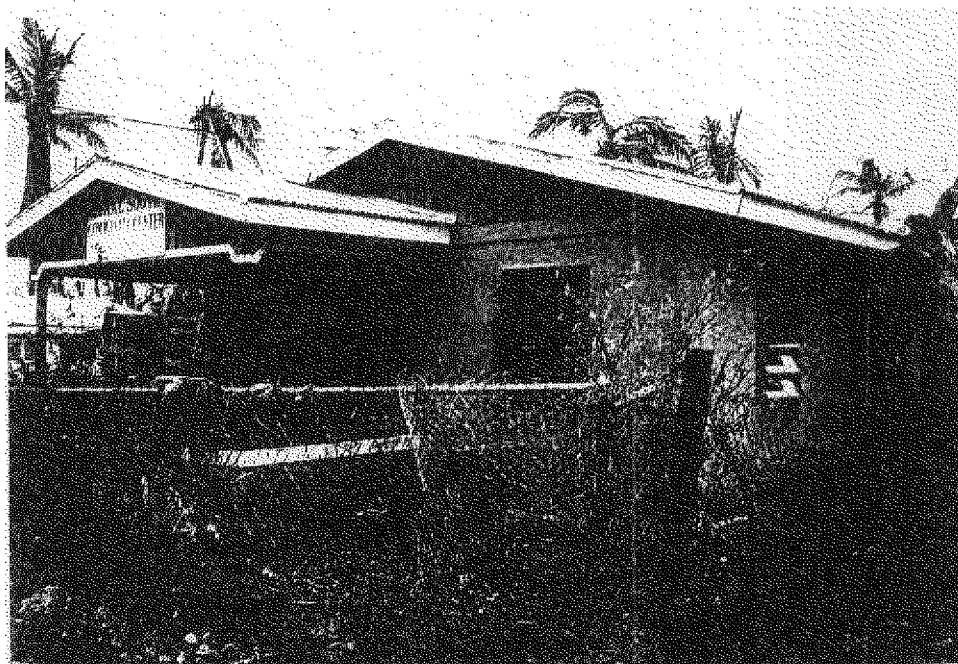
St John's II

- Side door damaged
- There were many leaks; the place was full of water immediately after Luis.

- None of the awning windows could be closed properly before Luis;
- This property does not belong to Government and it was not possible to establish whether the landlord had examined the building since Luis.
