2.25 Swetes Clinic

2.26 All Saints Clinic

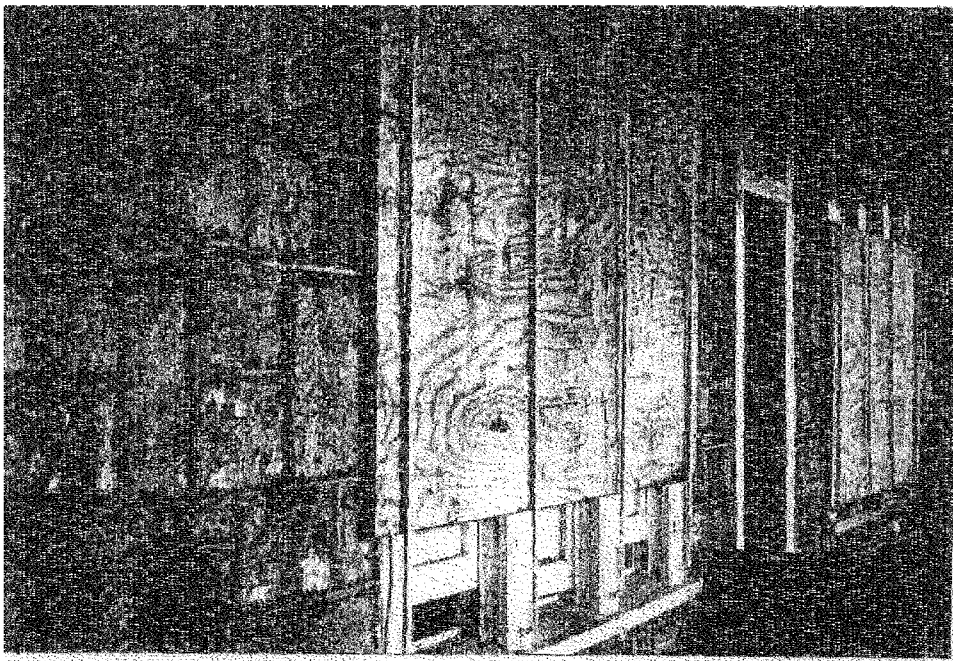
- The windows were broken before Luis, thus allowing a lot of water to enter the building.
- There were specific arrangements in the design for accommodating plywood hurricane shutters. There were shutters in place during Luis.

However they did not cover the windows completely.

Swetes - partial covering of windows.

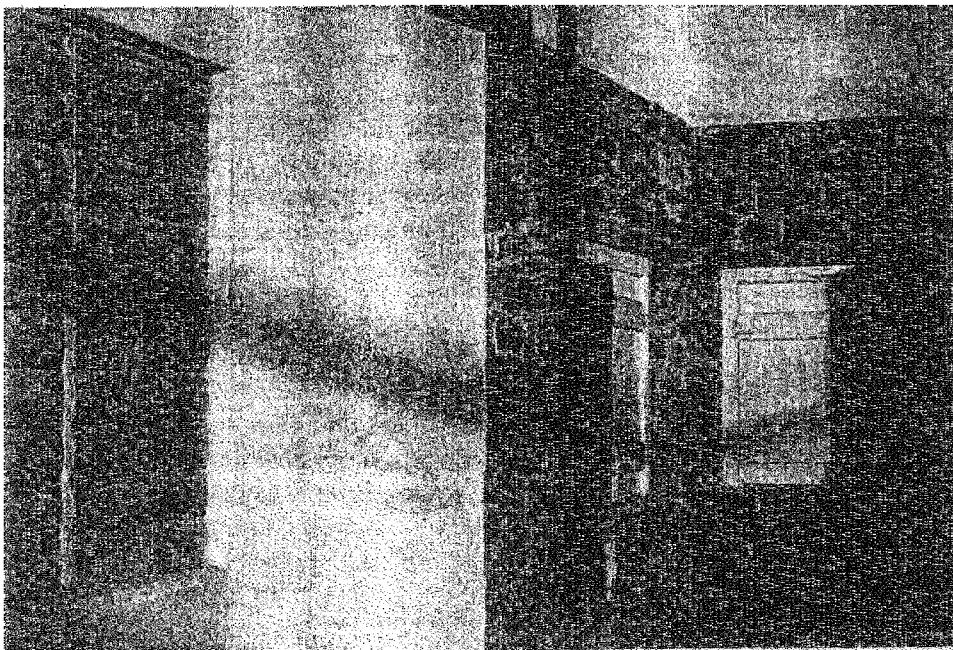
- The water tank showed evidence of leaking over a long period of time.
- The building was well provided with hurricane shutters.
- Unshuttered windows were of aluminium louvres which were not damaged.

All Saints - well protected windows.
