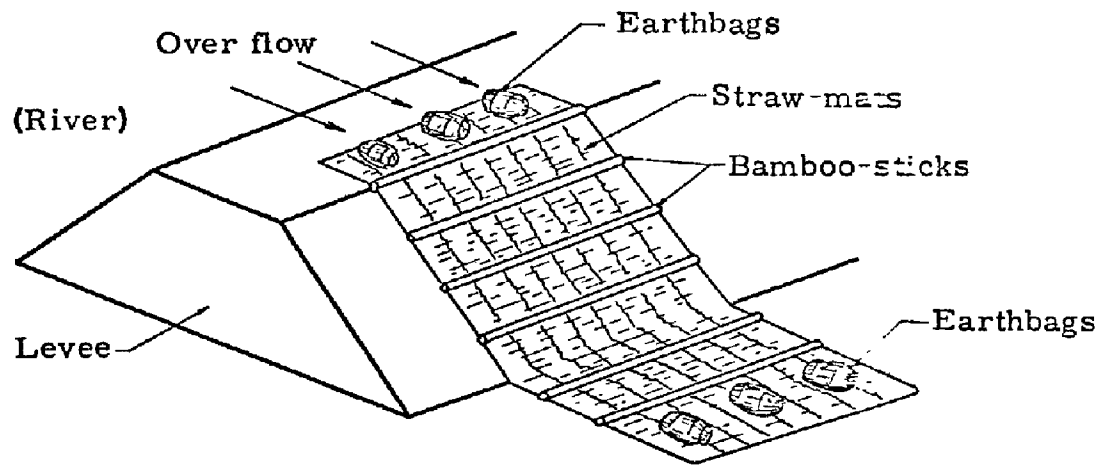
Fig. 3.19 Diagram of straw-mat protection to levee

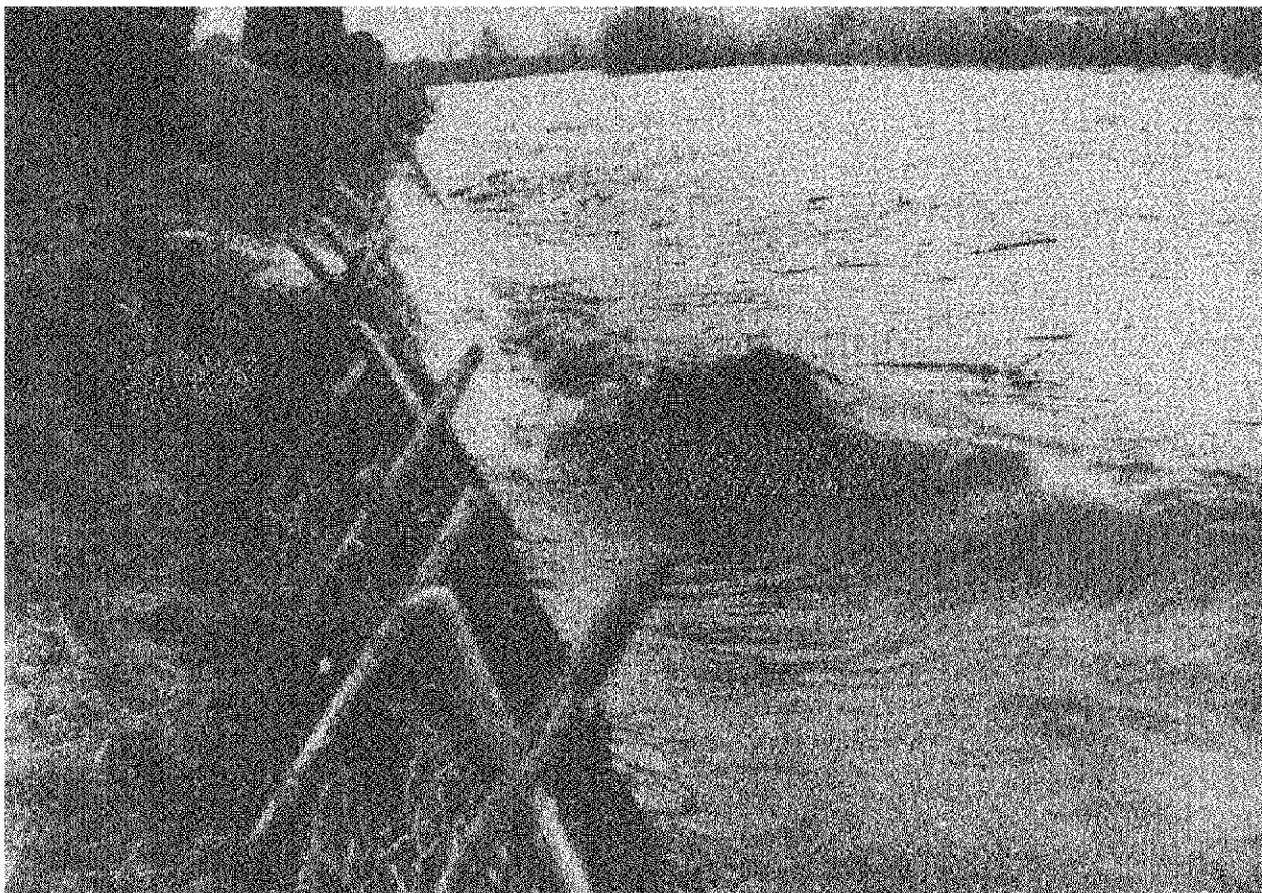
FIG. 3.20 — Wave protection with willow sausages

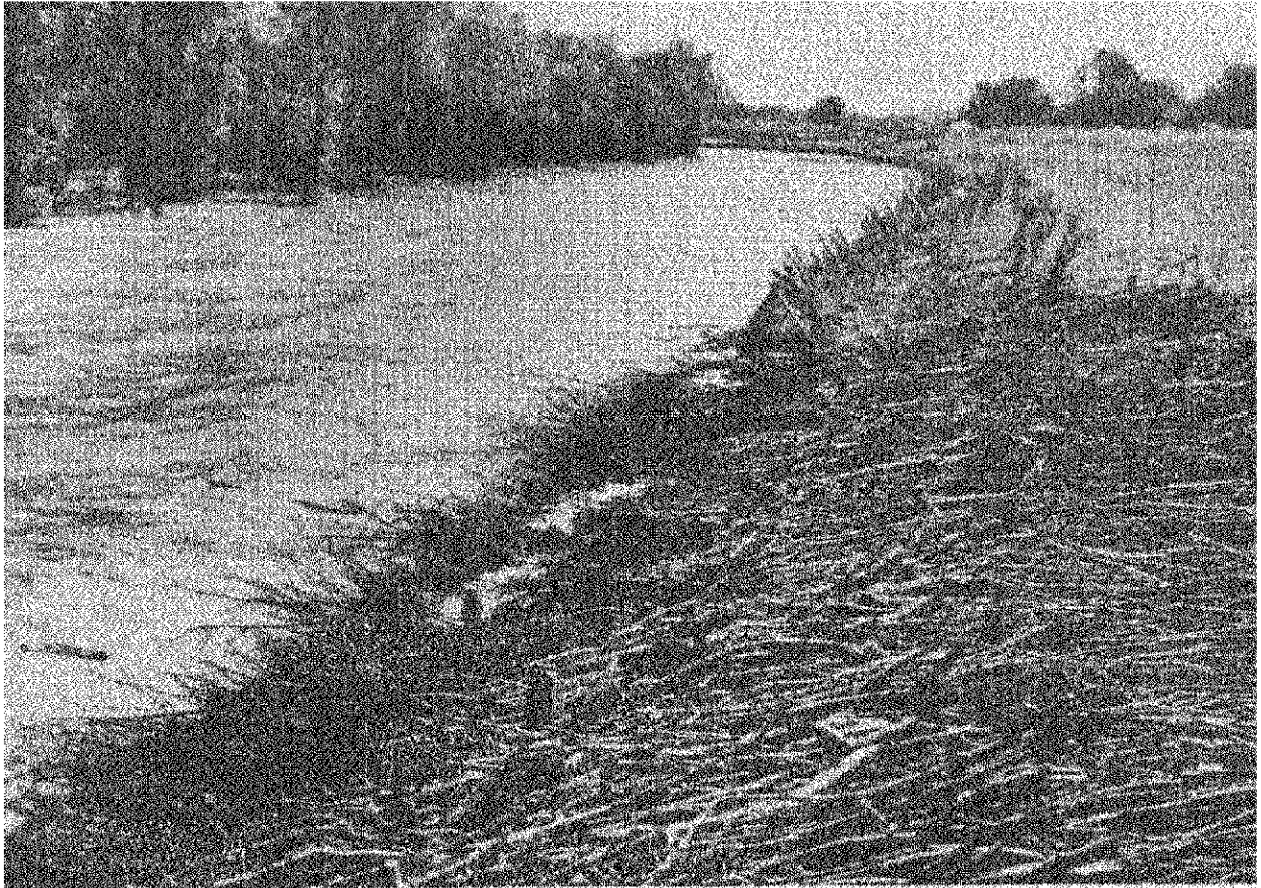
FIG. 3.21 - Wave protection with willow branch lining

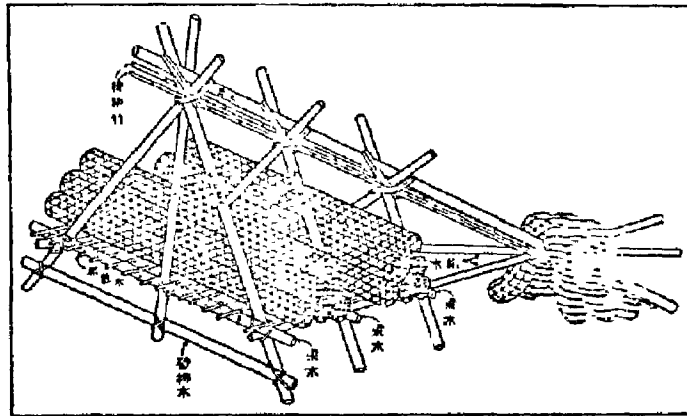
Fig. 3.22 Ushi or cow structure for bank protection against erosion

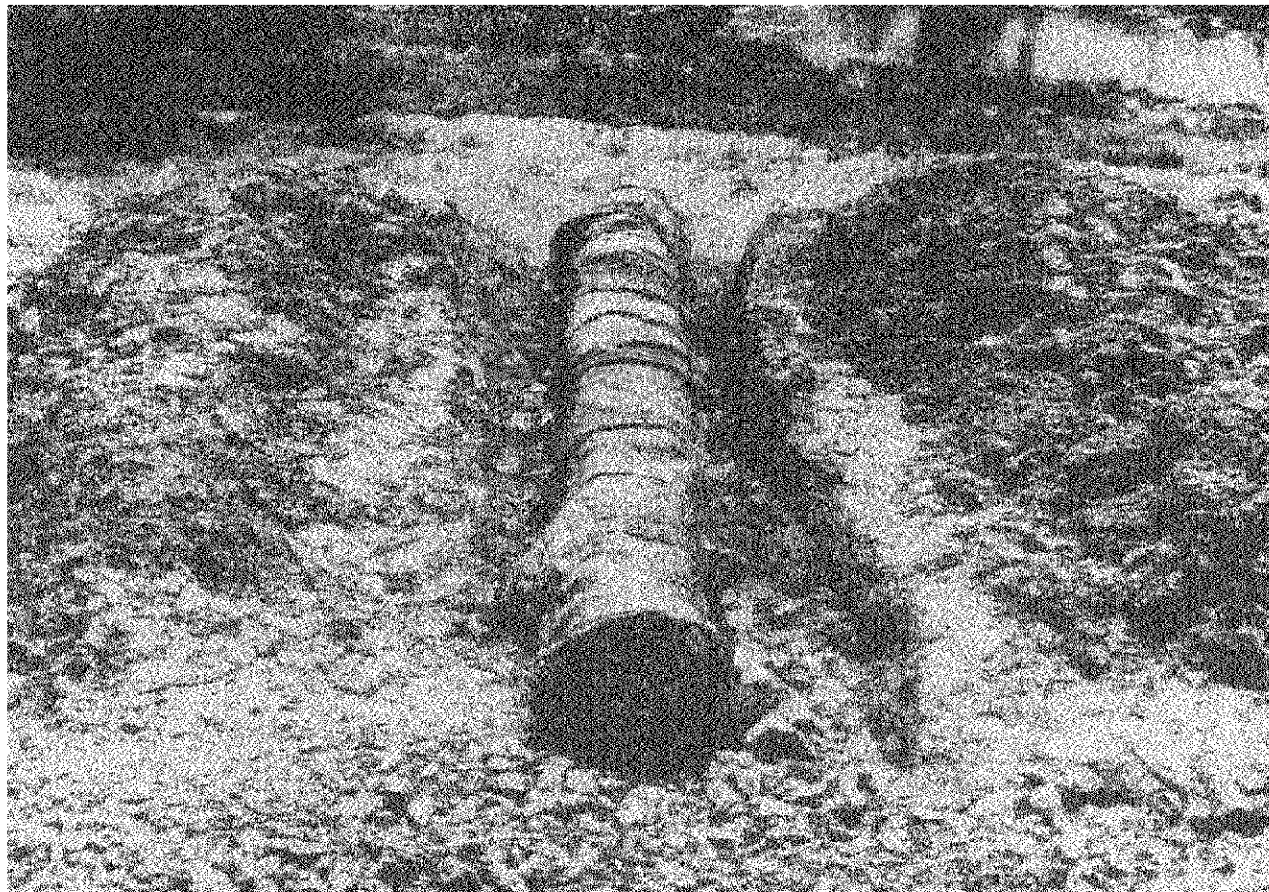
FIG. 3.23 - The construction of a willow-cylinder filter.
