Bagmati Barrage

Year of Construction (1983 - 1992) 1 = 404 m, gates 36 @ 9 m command area: 68,000 ha

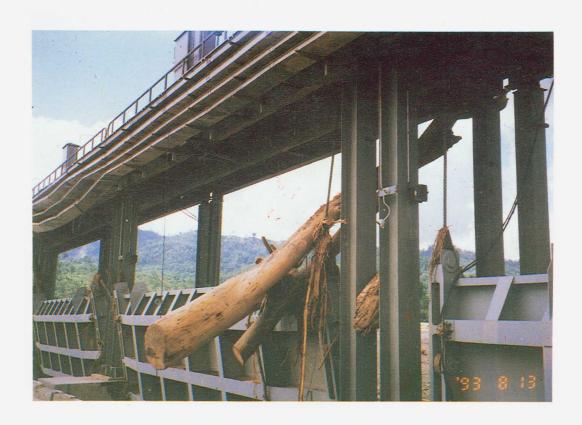
Wooden logs trapped in the regulating gate of Bagmati Barrage.
