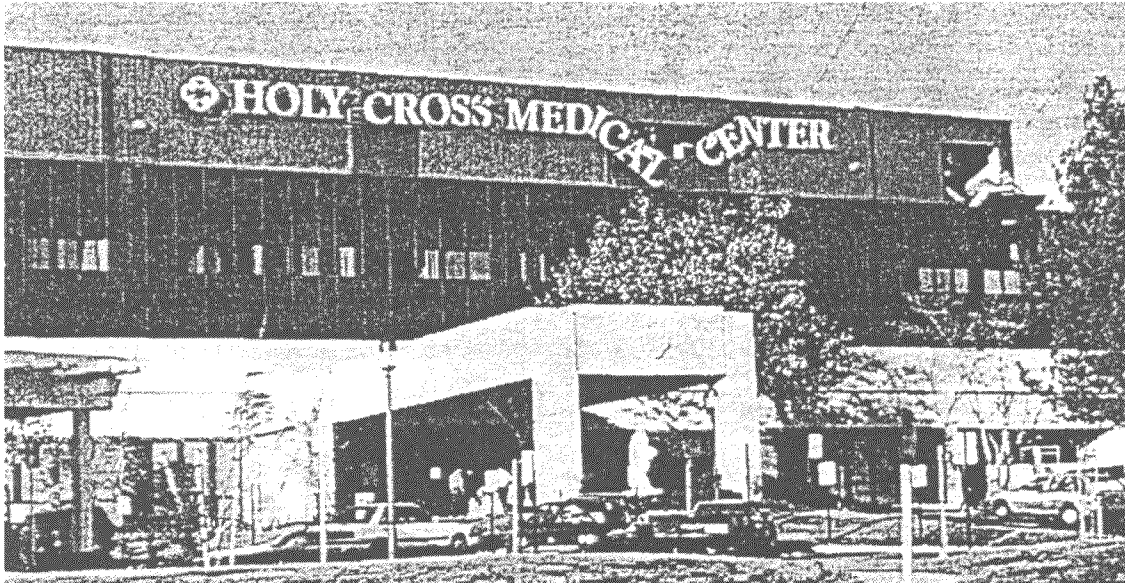
PHOTOGRAPH B7.6: Damage to penthouse HVAC fan units, Holy Cross Medical Center, which pounded out portions of the penthouse wall and caused damage to the sign. At this facility, HVAC outage was the single most disruptive effect of the earthquake. *photo credit: Bob Reitherman, Earthquake Engineering Research Institute*
