TECHNOLOGY TRANSFER

TECHNICAL IMPROVEMENTS

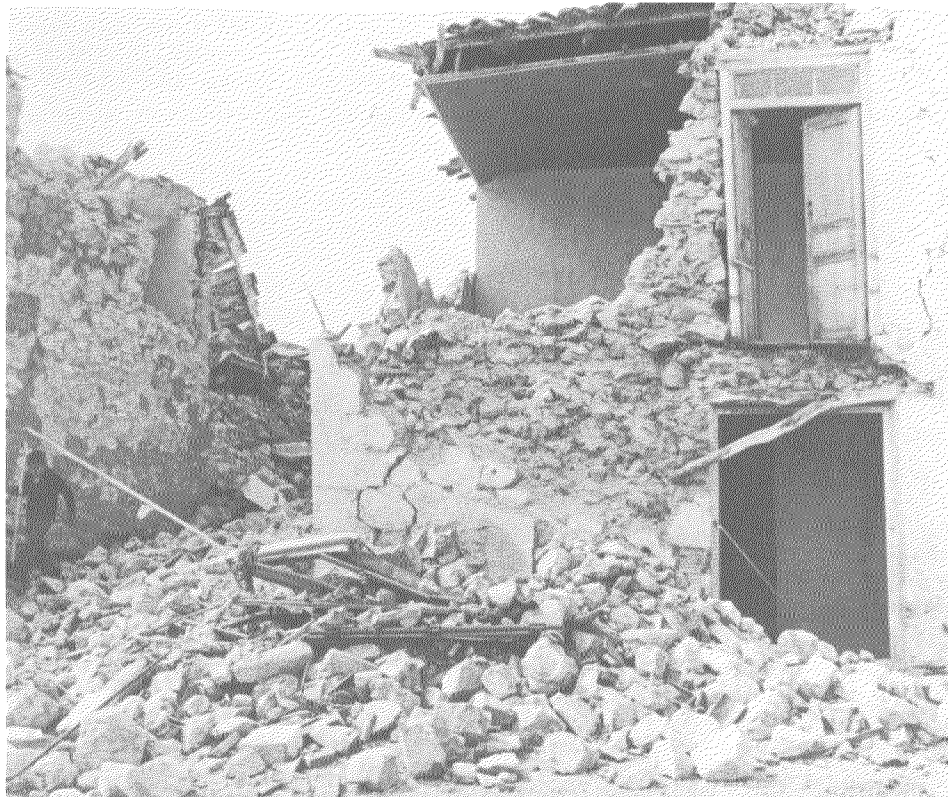
This masonry house in Corinth, Greece, was badly damaged in the earthquake of March 1981. Inadequate bracing of stones, and the use of mud mortar were two reasons for the failure. Techniques can be communicated to local craftsmen on a seismic building techniques

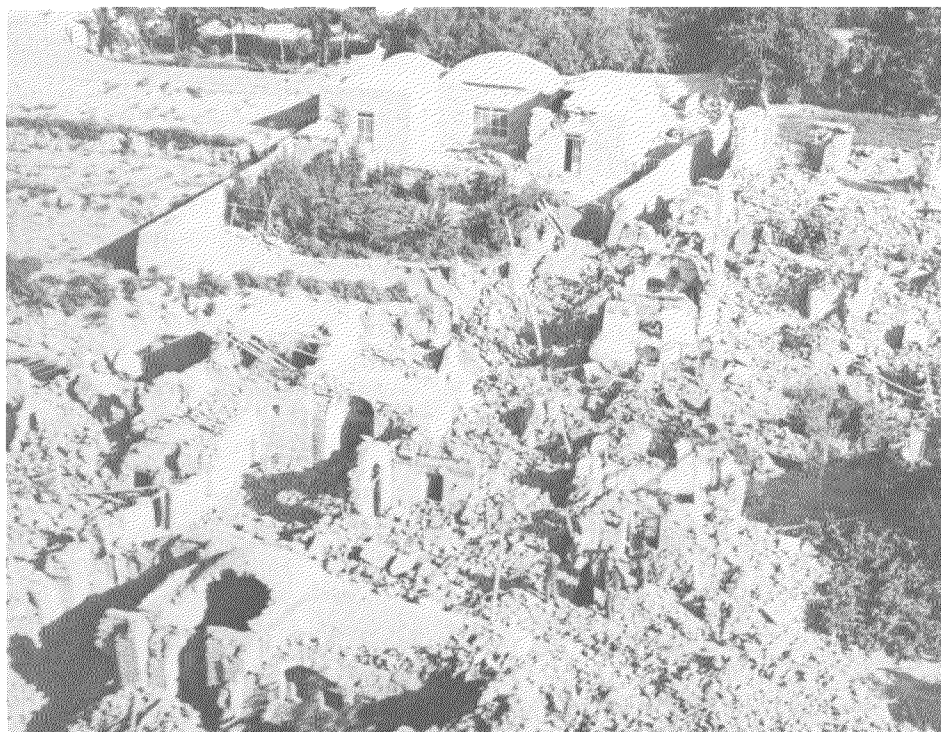
Housing with heavy earthen roofs supported on unreinforced, dried mud (adobe) walls is one of the most vulnerable types of construction in seismic areas. This is indicated in an example of failure, with high loss of life, from an earthquake at Golbaf, Iran, in 1980

Most research on emergency shelter and post-disaster housing has concentrated on the development of either whole structural units, or improved materials for use in the walls (e.g. stabilized adobe). Field experience has shown, however, that the majority of the problems encountered relate to the roof and roofing materials.
