Core Shelter Unit
Additional Photographs

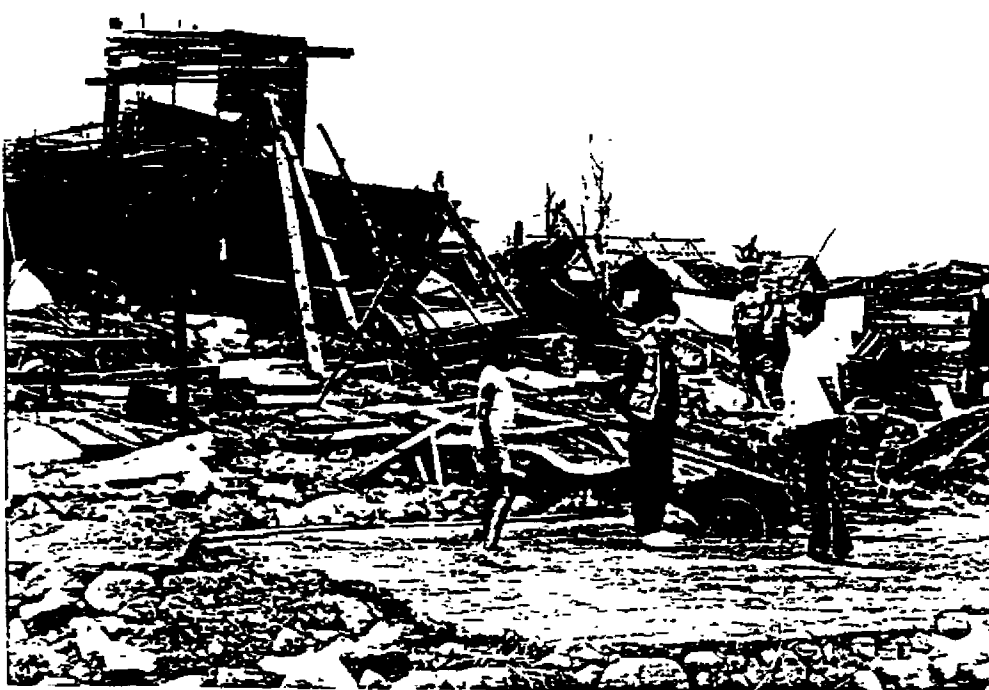
FIGURE 4. DESTRUCTION OF WOODEN HOUSES ALONG THE COASTLINE AFTER TYPHOON SISANG 1987

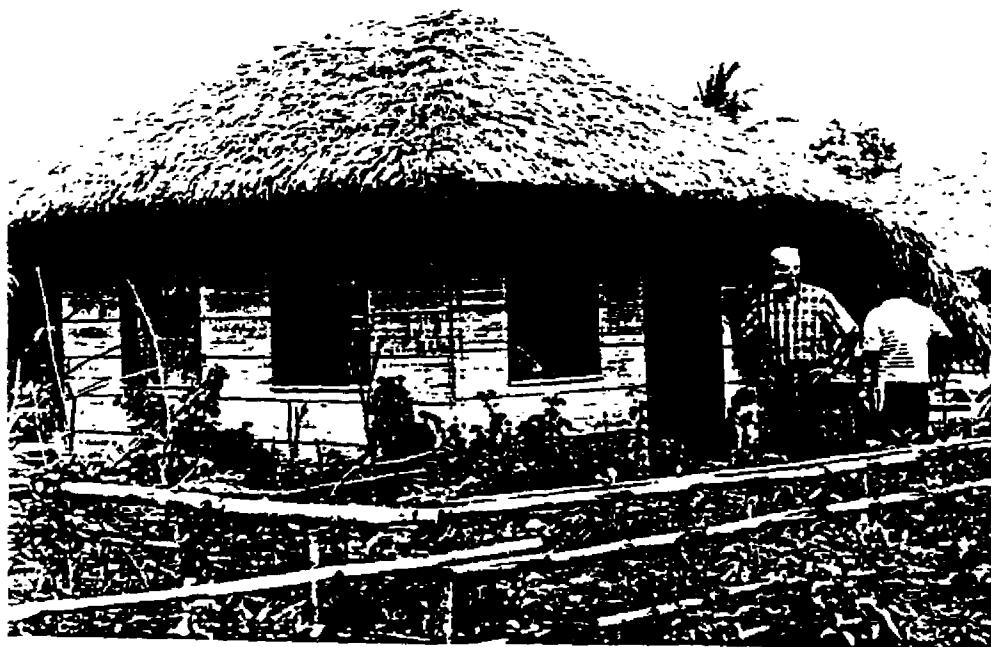
FIGURE 6. NEW DESIGN CORE SHELTER UNIT (CSU) IN USE USING LOCAL MATERIAL ANAHAW ROOFING AND LIGHT TIMBER BOARD SIDING

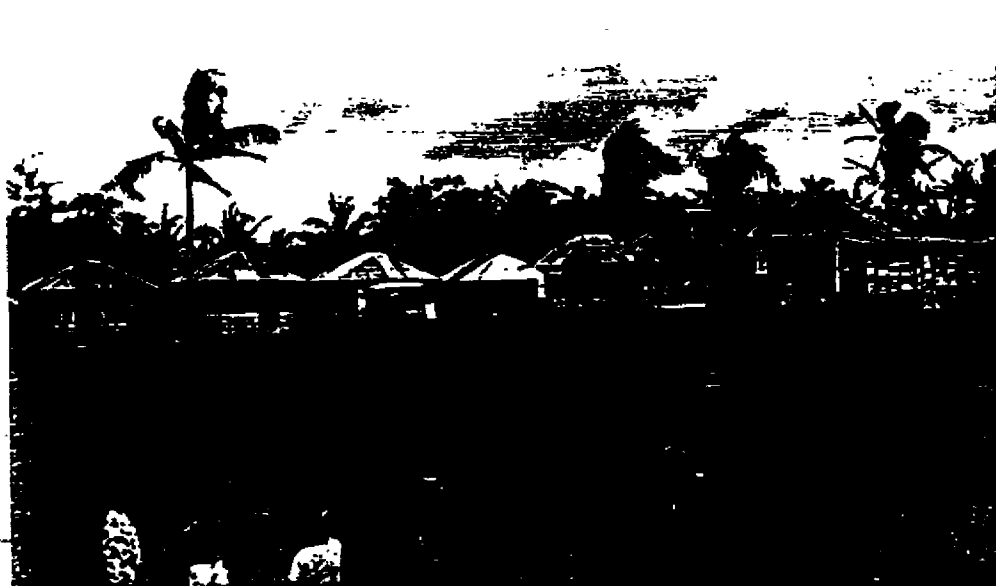
FIGURE 10. A GROUP OF HOUSES WITH SALVAGED GI SHEET ROOFING

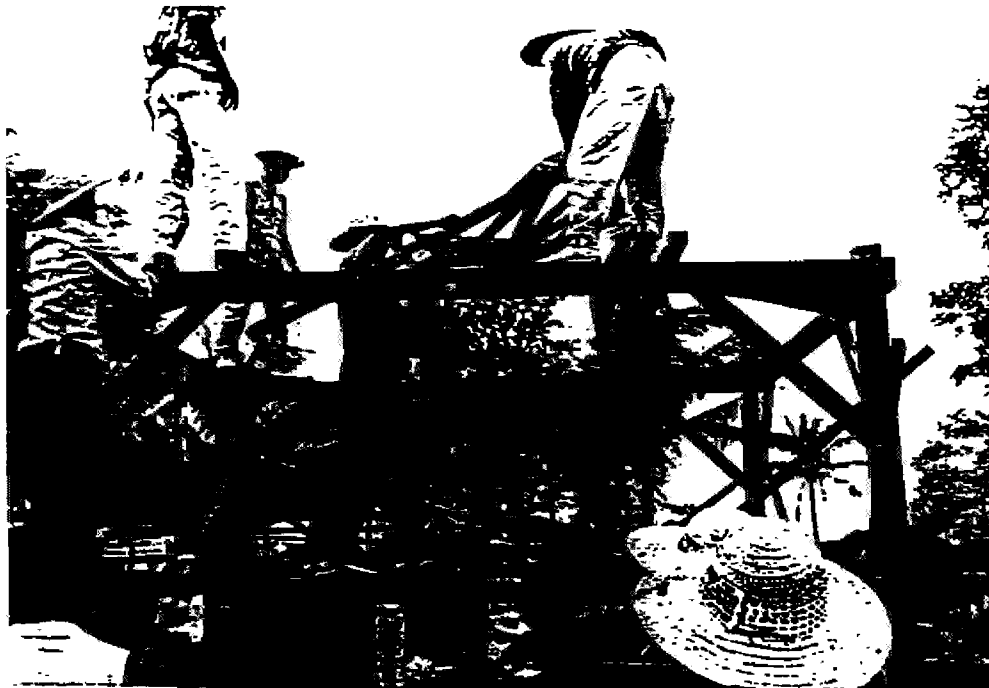
FIGURE 13. CONSTRUCTION OF CORE SHELTER UNIT IN PROGRESS AS A PART OF TRAINING FOR PROJECT STAFF
